# **LANYON CONSERVATION MANAGEMENT PLAN**

## **VOLUME 1**

**Prepared by Duncan Marshall, Australian Archaeological Survey Consultants Pty Ltd, Dr Lenore Coltheart, Context Pty Ltd, Geoff Butler & Associates, John Armes & Associates, Dr Michael Pearson & Ken Taylor**

**for the  
Cultural Facilities Corporation - ACT Historic Places**

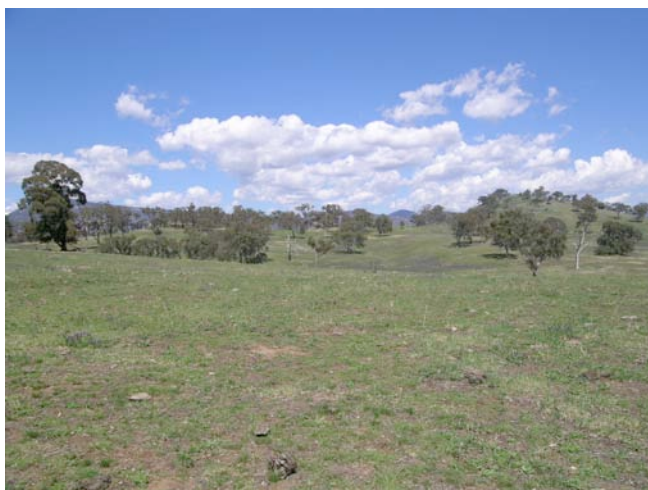
**Figure 11. The degree of woodland clearance is quite high on many parts of Lanyon**

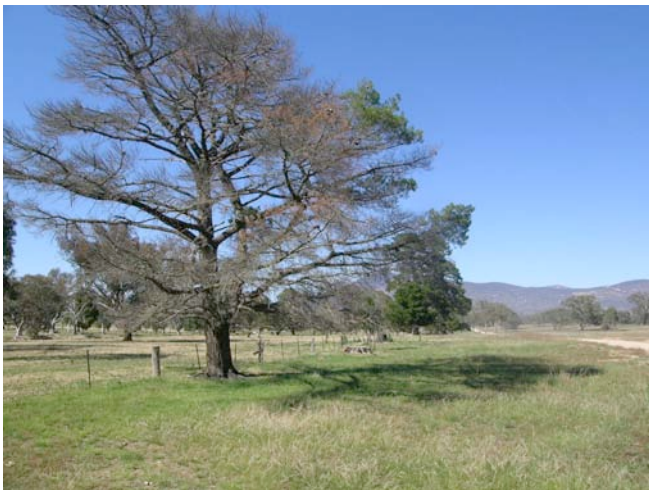
**Figure 18. A replacement driveway pine, probably 1960's, now dead**  
Source: Geoff Butler 2007

- consideration should be given to complete removal of the remnant and disjointed replacement pine **driveway plantings** from the main entrance to the entrance to the rural lease, and their comprehensive re-planting/ reconstruction with the original pine species;

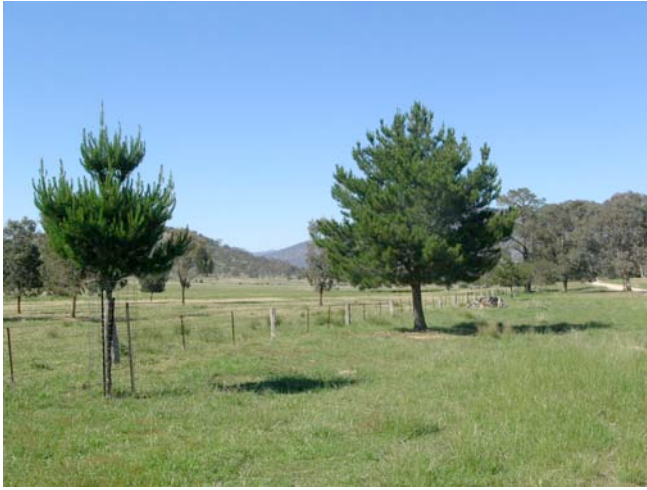
**Figure 19. More recent pine planting to recreate the entrance drive appear to have been undertaken at staggered intervals, and many are dead**

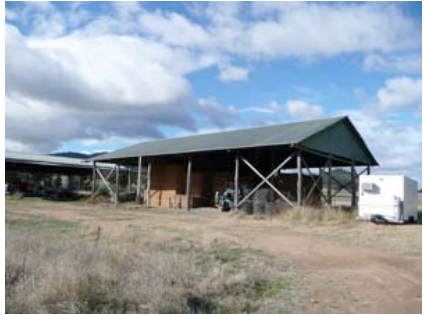
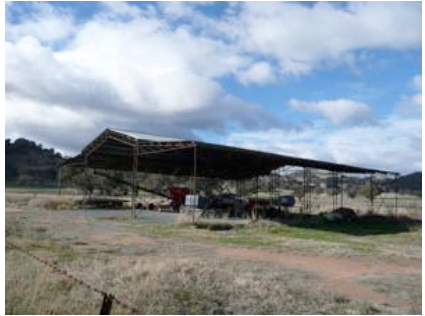
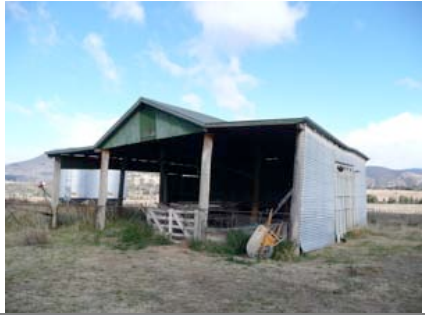
| Table 4. Summary Description of Buildings and Other Structures | |
|---|---|
| Portacon Hayshed & Storage Shed (Structure 9) | <p>corrugated iron gabled roof. It is in fair condition.</p> <p>The Portacon Hayshed is a metal framed shed with open sides, timber purlins and a corrugated iron gabled roof with skillions on two sides. It is in poor to fair condition.</p> <p>The Storage Shed is a timber pole framed shed with open sides on two elevations, corrugated iron cladding on the other sides, and a corrugated iron gabled roof with skillions on two sides. It is in poor condition with termite damage.</p> |

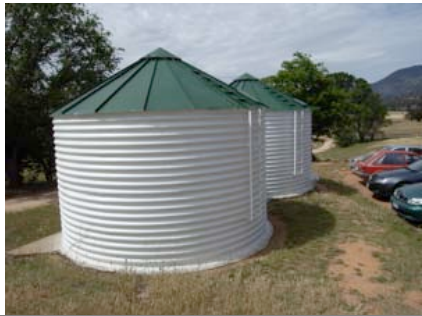
| Table 4. Summary Description of Buildings and Other Structures | |
|---|---|
| Silos (Structure 14) | <p>These two circular silos have painted corrugated iron walls and painted sheet metal conical roofs. They are mounted on concrete slabs and each has a fixed metal access ladder up a wall and on the roof. They are in good condition externally but poor condition inside.</p> |

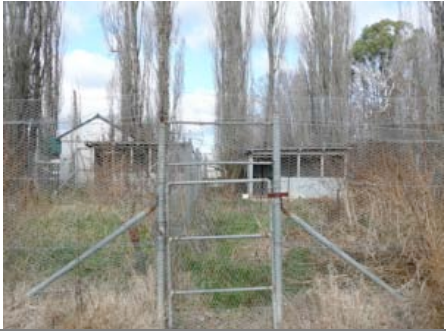
| Table 4. Summary Description of Buildings and Other Structures | |
|---|---|
| Fowl sheds, c1950s (Structure 16b) | <p>This structure consists of three small timber framed sheds with iron lining, concrete floors and bird wire on the north sides. They are in poor to fair condition.</p> |

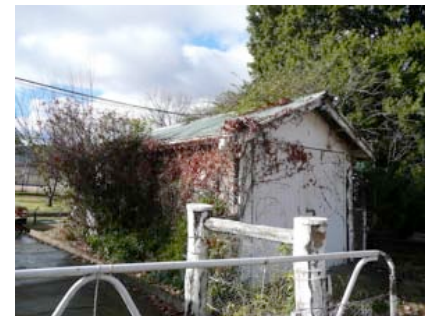
| Table 4. Summary Description of Buildings and Other Structures | |
|---|---|
| Manager's House Garage (Structure 22) | <p>This simple single car garage is timber framed and clad with fibro cement. It has a gabled corrugated iron roof, and painted timber garage doors. It is in poor to fair condition.</p> |

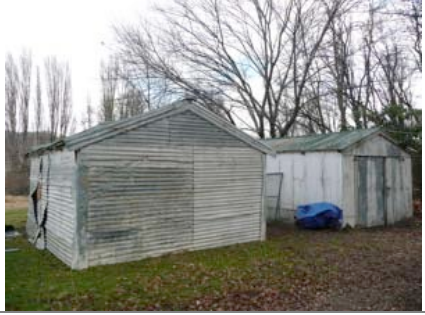
| Table 4. Summary Description of Buildings and Other Structures | |
|---|---|
| Sheds associated with Cottage 4 (Structures 25-26) | <p>These are two timber framed and corrugated iron clad sheds with gabled corrugated iron roofs. They are in poor to fair condition.</p> |

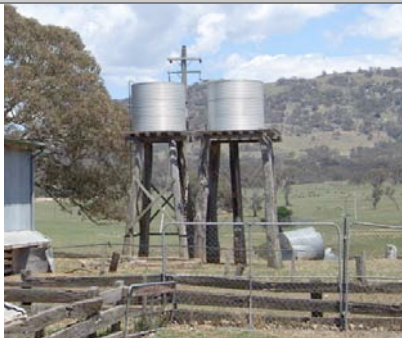
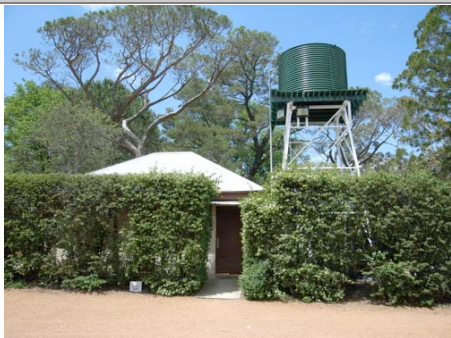
| Table 4. Summary Description of Buildings and Other Structures | |
|---|---|
| Cottage 6, Hart's Cottage/Gardener's Cottage including grounds and outbuildings, c1950s (Structures 35-36) | <p>A timber framed cottage clad in asbestos cement and weatherboard, with a corrugated iron gabled and skillion roof. An unusual detail is the sloping ceilings which suggests that the house had a skillion roof at one stage which was extended, and the gable roof added. There is a painted corrugated iron clad single garage, with a gabled corrugated iron roof and painted timber garage doors. The cottage is in fair condition and the garage in poor condition.</p> |

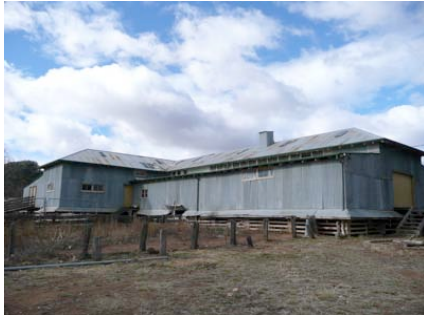
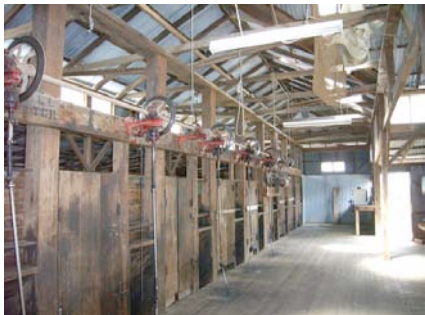
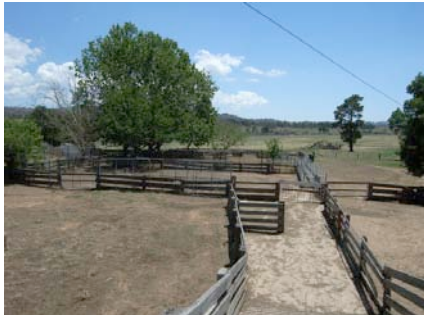
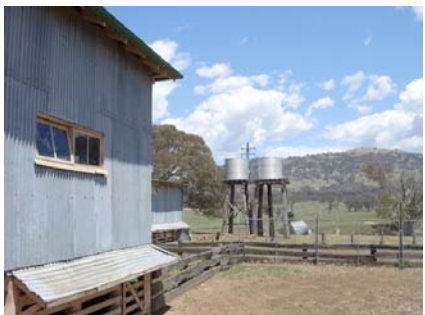
| Table 4. Summary Description of Buildings and Other Structures | |
|---|---|
| Woolshed, sheep yards, and spray dip, c1940s (Structure 41) <sup>4</sup> | <p>Built of timber, dressed hardwood and yellow box, and galvanised iron, this shed has six shearing stands. It has a timber structure and is clad with iron. The building has a T plan shape and hipped corrugated iron roof. The shed has a timber floor, slatted in the sheep holding pens. The fittings include the pens, gates, doors and machinery related to shearing, although the power source is now an electric motor. The shed is in fair condition.</p> <p>The yards are a mixture of timber post and rail, galvanised pipe, reinforced in places with temporary cyclone wire and pipe fence panels. The yards are in poor condition.</p> <p>The complex includes two galvanised water tanks mounted on tall timber platforms. The tanks are badly corroded.</p> <p>The spray dip has a concrete slab, pipe and timber yards, a corrugated iron enclosed spray area, and the remnants of the pump and piping. It is in poor to fair condition.</p> <div> </div> |

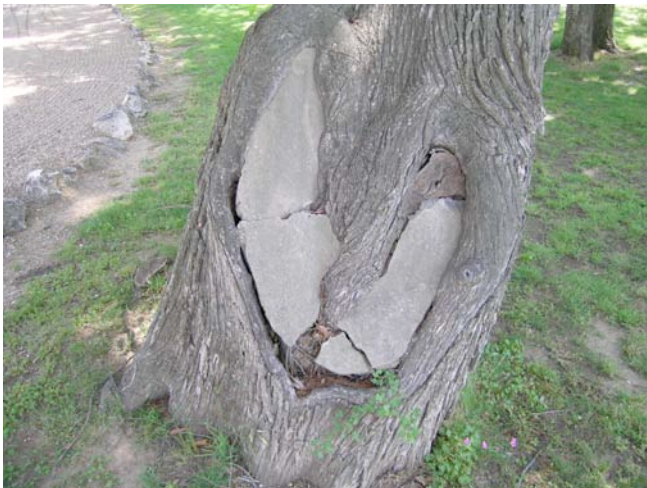
**Figure 88. Former maintenance repair to the hollow in an Elm is no longer of any benefit**

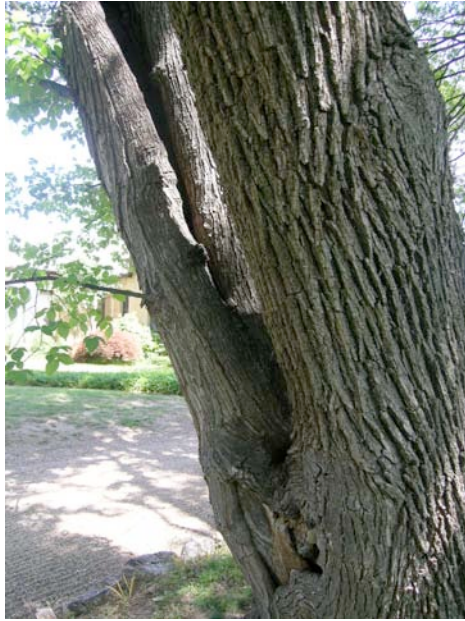
**Figure 89. Elm with deep-seated hollows on branch and trunk**

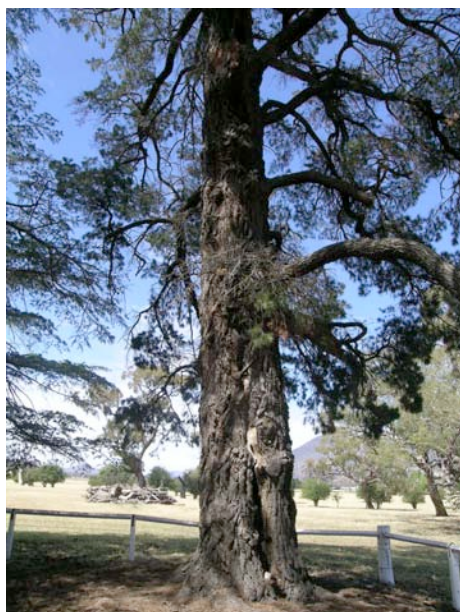
**Figure 92. Monterey Pine in Lanyon Cemetery – this tree is badly infested with dry rot**
