# **LANYON CONSERVATION MANAGEMENT PLAN**

## **VOLUME 1**

**Prepared by Duncan Marshall, Australian Archaeological Survey Consultants Pty Ltd, Dr Lenore Coltheart, Context Pty Ltd, Geoff Butler & Associates, John Armes & Associates, Dr Michael Pearson & Ken Taylor**

**for the  
Cultural Facilities Corporation - ACT Historic Places**

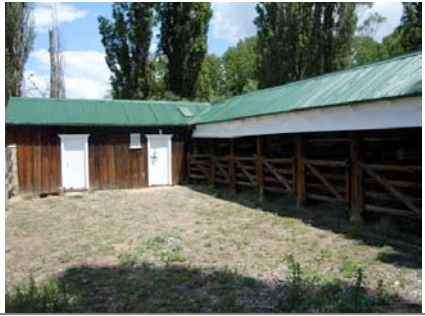
| Table 4. Summary Description of Buildings and Other Structures | |
|---|---|
| New Stables, c1930s (Structure 16) | <p>Extended in the 1950s, the stables consists of two sections, one of two rooms on the south and the other of nine horse stalls to the west. The two rooms comprise a saddle room and a harness room. This section is timber framed with stained vertical timber cladding and a gabled corrugated iron roof. The horse stalls are timber framed with a gabled iron roof and dirt floor. Together with the Cow feed shed (Structure 16a) on the north and timber yards, the stables form a U shaped complex. The stables are in fair condition.</p> |

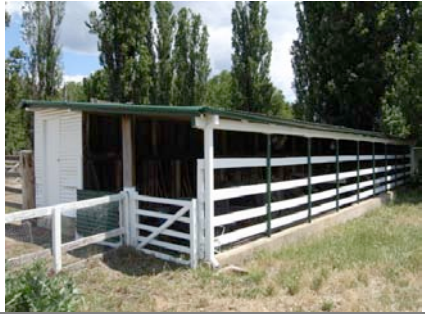
| Table 4. Summary Description of Buildings and Other Structures | |
|---|---|
| Cow feed shed, c1950s (Structure 16a) | <p>This shed is a simple timber framed and corrugated iron clad structure, with a low pitched iron roof. The floor and feed trough are made of concrete. It is open to the east and north. Together with the New Stables (Structure 16) to the south and timber yards, the shed forms a U shaped complex. The building is in fair condition.</p> |

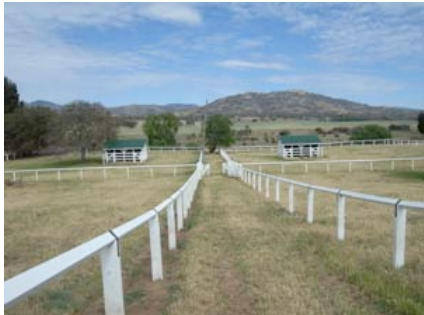
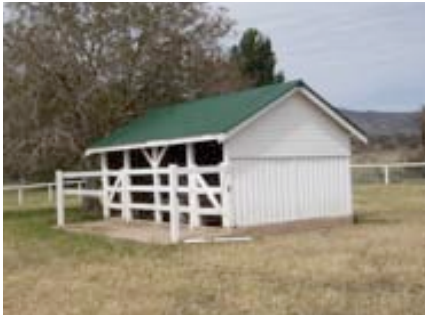
| Table 4. Summary Description of Buildings and Other Structures | |
|---|---|
| Loose Boxes and Pony Yards, c1950s (Structures 17-20) | <p>The four loose boxes have timber frames and painted weatherboard walls with gabled painted corrugated iron roofs. The yards are painted post and rail construction. They are in good condition.</p> |

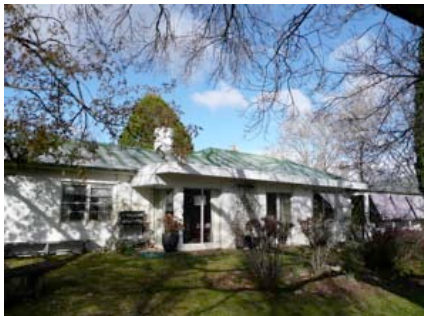
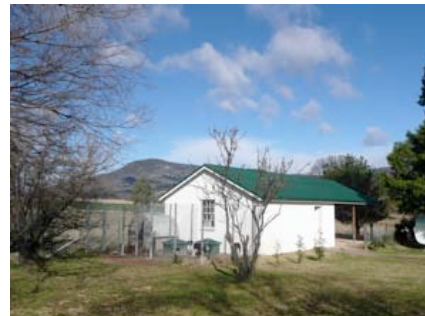
| Table 4. Summary Description of Buildings and Other Structures | |
|---|---|
| Manager's House, c1860s (Structure 21) | <p>The core of this house is a four-room brick cottage. Extensions are in brick, and date from about the 1930s, 1950s and 1970s. There is a semi-enclosed verandah to three sides, and a sheet metal roof. There is a galvanised iron and timber shed and workshop behind the house. Fowl houses and dog kennels and runs were established in keeping with management needs. Some of the kennels were demolished in 2002 and there is only one remaining. The house is in fair condition.</p> |

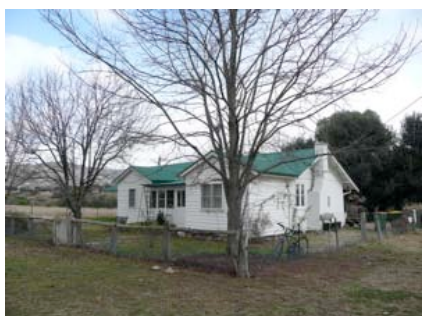
| Table 4. Summary Description of Buildings and Other Structures | |
|---|---|
| Cottage 3, Curator's Cottage/General Hand's Cottage, including grounds and outbuildings, c1935 (Structure 27) | <p>This cottage is timber framed weatherboard with a painted corrugated iron roof. It originally consisted of one rectangular gabled building but was extended on the eastern and southern sides c1965. It is in good condition.</p> |

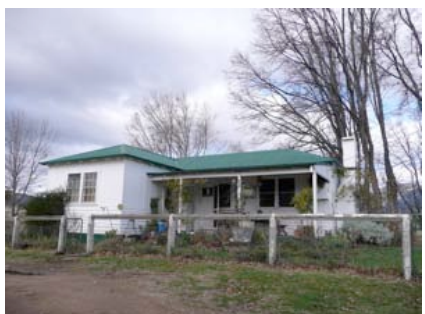
| Table 4. Summary Description of Buildings and Other Structures | |
|---|---|
| Cottage 2, Gardener's Cottage/Mechanic's House, including grounds and outbuildings, c1935 (Structure 28) | <p>A timber framed cottage clad with asbestos cement and weatherboard, with a painted corrugated galvanised iron roof. It has a verandah to the north. The house is in good condition.</p> |

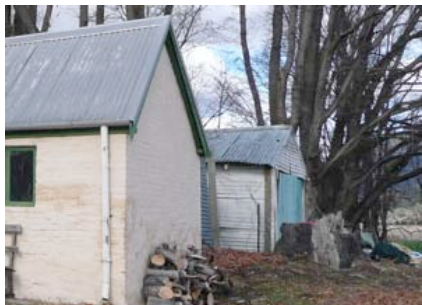
| Table 4. Summary Description of Buildings and Other Structures | |
|---|---|
| Wilson's Cottage/<br>House shed, c1950<br>(Structure 30) | <p>The shed is constructed of corrugated iron cladding with a timber frame, and a gabled corrugated iron roof. It has painted timber garage doors. It is in fair condition.</p> |

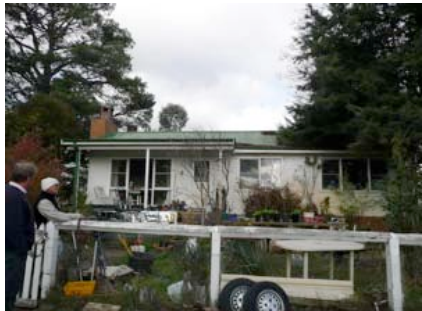
| Table 4. Summary Description of Buildings and Other Structures | |
|---|---|
| Cottage 1, Groom's<br>Cottage, including<br>grounds and<br>outbuildings, c1965<br>(Structure 31) | <p>This weatherboard cottage with a timber frame has brick chimneys and a corrugated iron roof. It is in fair condition.</p> |

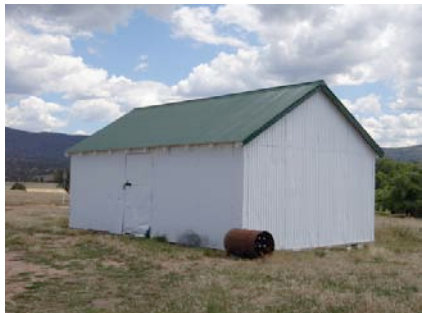
| Table 4. Summary Description of Buildings and Other Structures | |
|---|---|
| Grain Shed (Structure<br>33) | <p>This shed is timber framed with corrugated iron walls and a gabled corrugated iron roof. There is a single metal clad door to the east. The shed is in fair condition.</p> |

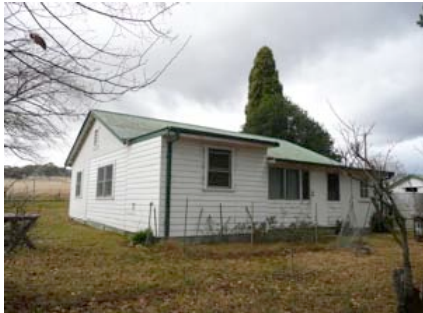
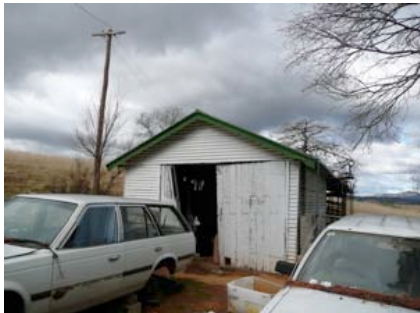
| Table 4. Summary Description of Buildings and Other Structures | |
|---|---|
| Cottage 6, Hart's Cottage/Gardener's Cottage including grounds and outbuildings, c1950s (Structures 35-36) | <p>A timber framed cottage clad in asbestos cement and weatherboard, with a corrugated iron gabled and skillion roof. An unusual detail is the sloping ceilings which suggests that the house had a skillion roof at one stage which was extended, and the gable roof added. There is a painted corrugated iron clad single garage, with a gabled corrugated iron roof and painted timber garage doors. The cottage is in fair condition and the garage in poor condition.</p> |

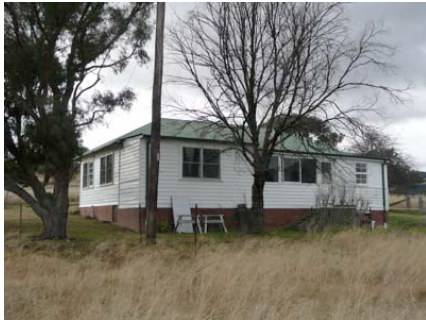
| Table 4. Summary Description of Buildings and Other Structures | |
|---|---|
| Cottage 5, Boorman's Cottage/General Hand's Cottage, including grounds and outbuildings, c1950s (Structures 37-38) | <p>A timber framed painted weatherboard cottage on brick piers with a hipped corrugated iron roof, lined internally with hardboard. It is suggested this cottage was brought from Harman. It is in fair to good condition.</p> |

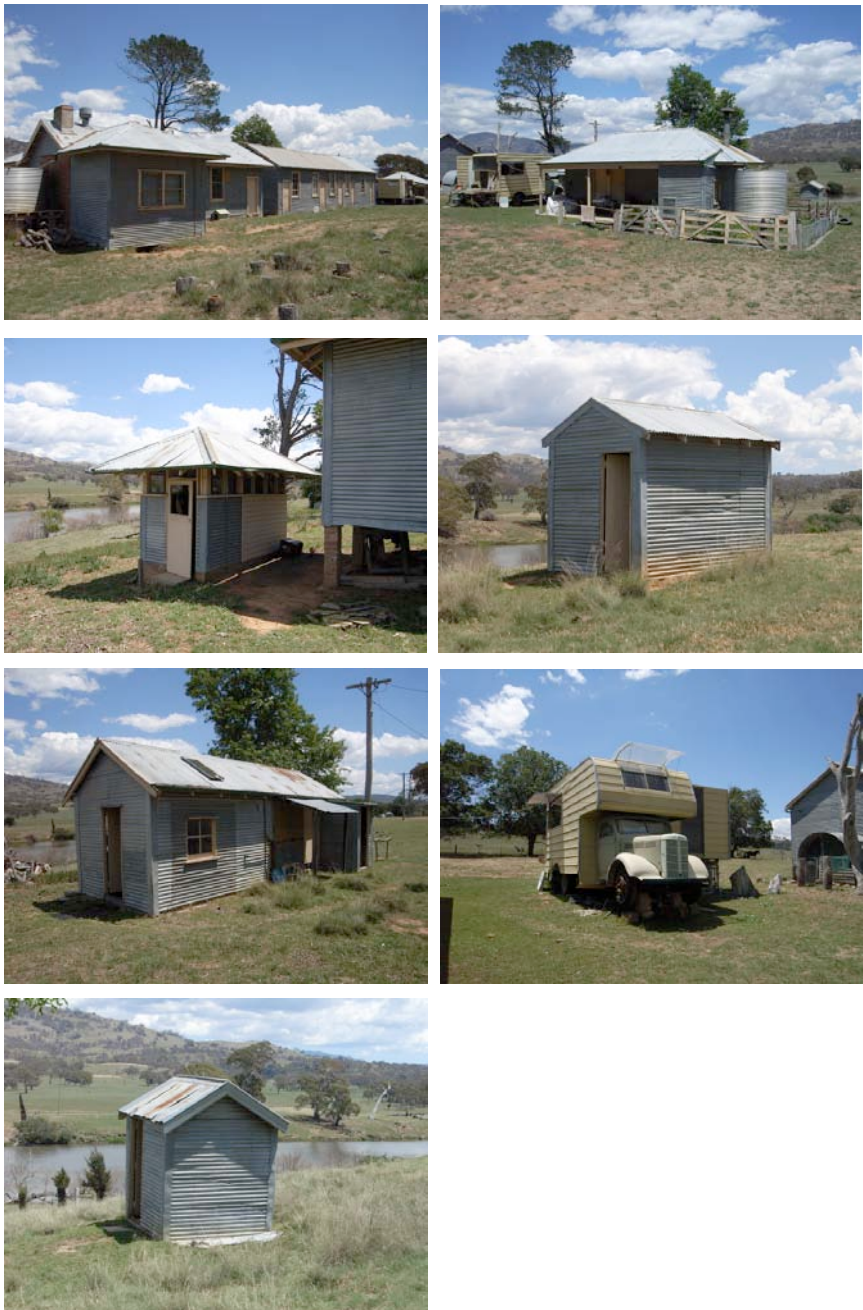
| Table 4. Summary Description of Buildings and Other Structures | |
|---|---|
| | <p>The shearers' quarters and kitchen is a substantial building while the other buildings are more modest in scale. The minor buildings include a former meat house, ablution block, laundry and stores. The condition of the buildings is poor to fair.</p> |

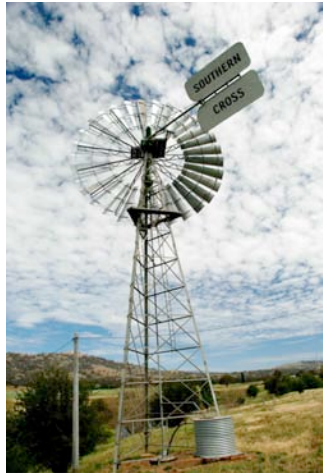
| Table 4. Summary Description of Buildings and Other Structures | |
|---|---|
| Windmill, c1940s (Structure 42) | <p>The Southern Cross ‘Seneschal’ windmill was at 30 feet in diameter (9.14 metres) one of the largest standard models made in Australia. Its tower is 20 metres tall and the windmill has a span of 10 metres. It is in good condition.</p> |

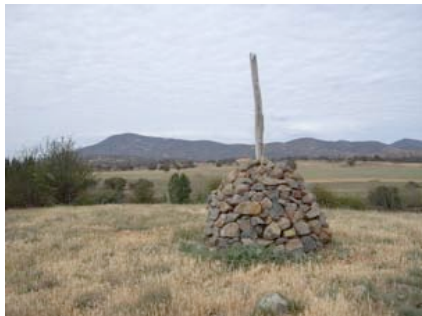
| Table 4. Summary Description of Buildings and Other Structures | |
|---|---|
| Trig Point Cairn, c1940s (Structure 43) | <p>The timber survey marker pole has a base cairn of dry field stones. The structure is in fair condition.</p> |

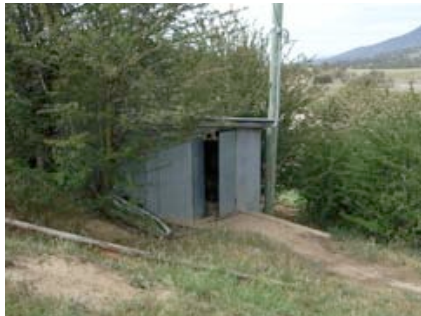
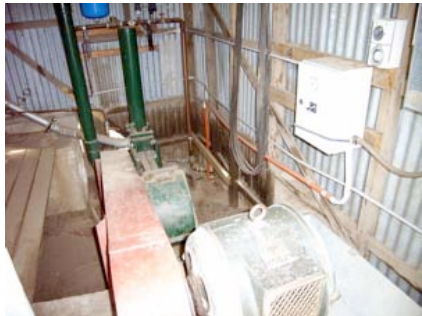
| Table 4. Summary Description of Buildings and Other Structures | |
|---|---|
| Pump House and pump c1950s (Structure 51) | <p>This structure is a simple timber framed building clad with unpainted corrugated iron, and a low-pitched iron roof. It has a pair of sheet metal double access doors. The building houses a variety of pump equipment. The structure is in fair condition.</p> |

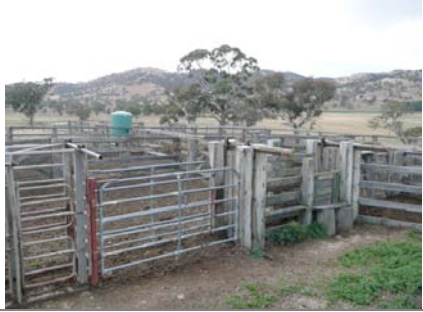
| Table 4. Summary Description of Buildings and Other Structures | |
|---|---|
| Cattle yards (Structure 53) | <p>The yards are mixture of timber and metal, and of varying age and condition. There is a modern crush. New yards are being constructed adjacent to the existing. The timber elements are in poor condition.</p> |

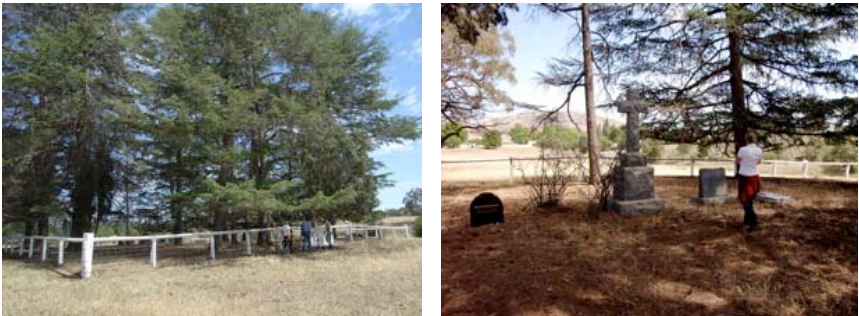
| Table 4. Summary Description of Buildings and Other Structures | |
|---|---|
| Cemetery (Structure 54) | <p>The cemetery is a small square plot of land in a paddock, fenced with a painted post, rail and wire fence. Inside the plot are a number of mature exotic evergreens as well as several stumps of trees now removed. There are five stone and metal grave markers, and a metal interpretive panel. There are 36 recorded burials but about 50 people are believed to have been buried in the cemetery. The cemetery is in fair condition.</p> |

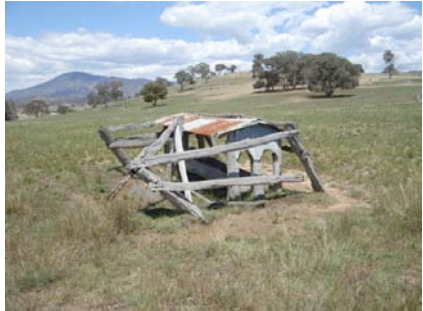
| Table 4. Summary Description of Buildings and Other Structures | |
|---|---|
| Wooden salt trough | <p>The trough is a hollowed timber log trough with a gabled corrugated iron shelter supported on timber posts, and surrounding timber post and rail fence. The trough is located in the northeastern part of the rural lease. The trough is in fair condition though the surrounding fence is partly collapsed and in poor condition.</p> |

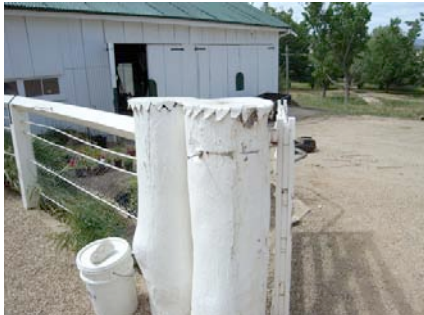
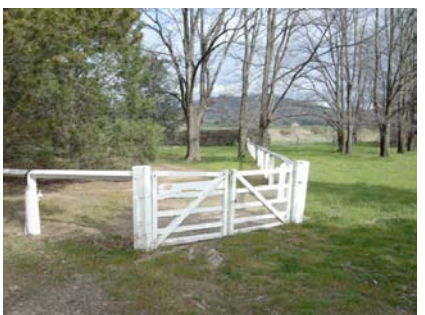
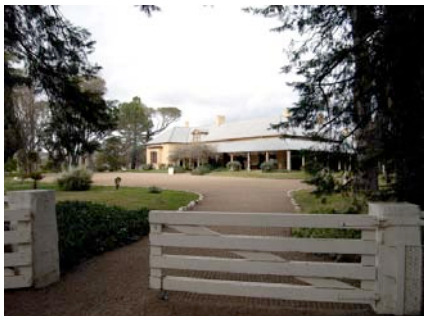
| Table 4. Summary Description of Buildings and Other Structures | |
|---|---|
| Fences and Gates | <p>There are many varieties of gates and fences constructed of timber, metal and wire. They date from various periods and are in variable condition, from poor to good condition.</p> |

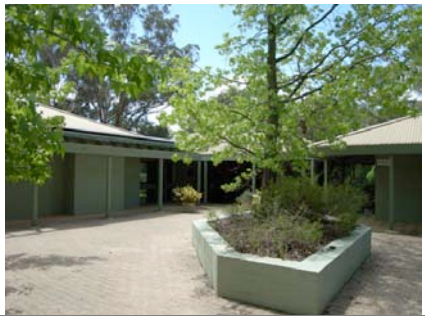
| Table 4. Summary Description of Buildings and Other Structures | |
|---|---|
| former Nolan Gallery building | <p>The gallery is a series of linked pavilions constructed of concrete slab floors, painted bagged brickwork walls, hipped corrugated iron roofs, with timber verandah posts and fascias. The gutters are concealed behind the fascias. The buildings are in good condition.</p> |

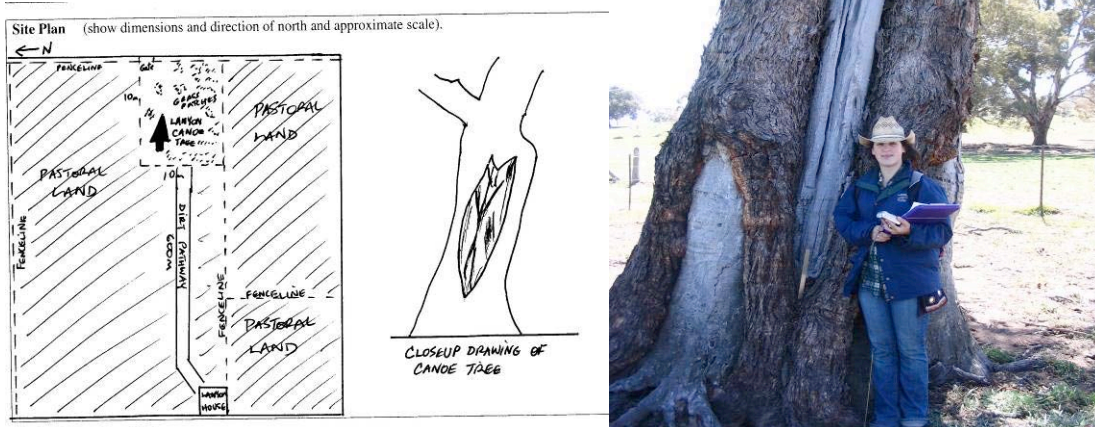
A 12 x 8 metre barbed wire fence (with gate) has recently been erected around the perimeter of the scarred tree, presumably as a measure to protect the tree from impacts associated with stock activity. The fence has been successful in keeping stock away from the tree. Numerous erosion scalds caused by cattle and sheep activity are present around the base of the tree, showing that until recently the tree was been utilised by stock for shelter.

Surface visibility within the perimeter fence line around the tree was generally good (70%) due to the presence of stock erosion areas. Outside the fence, visibility was restricted to around 30% due to grass cover. An inspection was made around the general vicinity of the tree in attempt to identify any associated stone artefacts. None were located.

Figure 94. Lanyon Canoe Scar - mud map, drawing of scar and picture

1. This site should be placed onto the ACT Heritage site register.
2. A 12 x 8 metre barbed wire fence with gate has recently been erected around the perimeter of the scarred tree, presumably as a measure to protect the tree from impacts associated with stock activity. The fence has been successful in keeping stock away from the tree, which is important for the long term preservation of this site. The fence should be retained, and regular inspections made to ensure that it is in a good state of repair.
3. Keeping stock away from the perimeter of the tree will result in an increased build up of grass within the fenced area. This may increase the susceptibility of the site to damage by fire. To mitigate against this risk, the grass within the fenced area should be regularly trimmed, once each spring and summer, and any leaf litter removed.

4. Periodically, once a year, the tree should be inspected by someone with the appropriate expertise (eg. an Arborist), with the aim of monitoring the health of the tree. Appropriate measures should be implemented if the health of the tree is deteriorating.
5. The RAOs who participated in the field assessment have stated that they would prefer to have the barbed wire fence erected around the tree replaced with a wood fence. This can be implemented as a medium term management strategy (2-5 years).

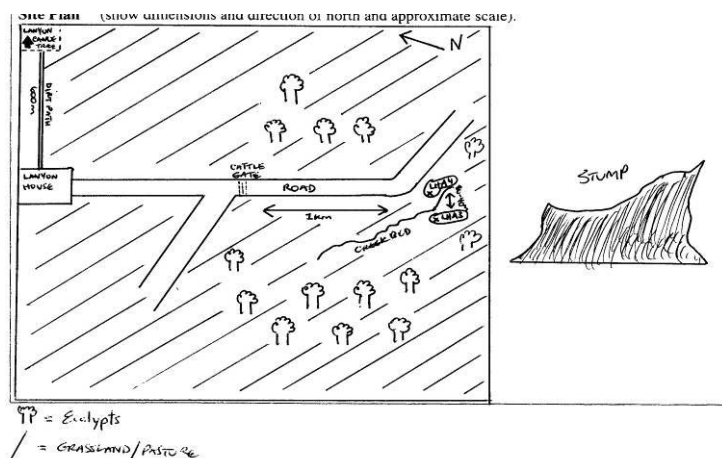
The site *LHA4* was previously identified by Winston-Gregson (1985c). The field team re-visited the general area of the site by entering the grid references into a GPS. What is assumed was the site was relocated and the field team took updated GPS readings to mark the location. This area is pastoral grasslands with stands of eucalypt trees. A burnt stump corresponds with the general area of the grid reference and could possibly be this site. The stump shows no sign of a scar. The site has either been destroyed or is difficult to find because there was no GPS usage when it was recorded. There are no other scarred trees identified in the general vicinity of the area.

Figure 95. LHA3 – mud map and close-up drawing of stump

1. This site should be placed onto the ACT Heritage site register.
2. All that remains at the reported location of this site, a scarred tree, is the stump of the tree base. The remainder of the tree has been destroyed, including the reported scar. On this basis it is recommended that there are no further archaeological requirements for this site.

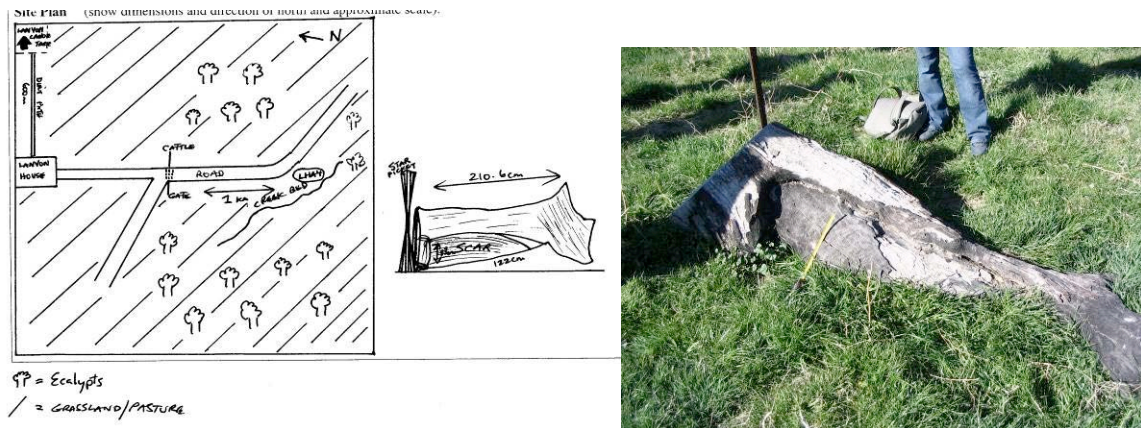
visited the general area of the site by entering the grid references into a GPS. What is assumed was the site was relocated and the field team took updated GPS readings to mark the location. The tree is situated approximately 50 metres east of the Lanyon Homestead driveway. This area is pastoral grasslands with stands of eucalypt trees. The condition of the tree is very poor. It has been cut down with a chain saw, is on its side and shows signs of burning by fire. The surface visibility around the tree is 0% because of grass cover. The length of remaining tree is 210.6 cm. The scar's length is 122 cm, the width in the middle is 33 cm and the depth of regrowth at the remaining end is 7 cm. A star picket at the base of tree marks where it stood. There are no axe marks visible, but much of scar is burnt. No artefacts were found near the tree and the potential for any is low.

Figure 96. LHA4 – mud map, close-up drawing of remaining scar and picture

1. This site should be placed onto the ACT Heritage site register.
2. Site LH4, a scarred tree, is dead and has fallen onto the ground. It is being subject to wood rot and insect infestation, and is at risk from fire. Urgent action is required to mitigate against this.
3. The most effective mitigation measure in this instance is to salvage the section of the tree with the scar on it, and to relocate this scar to an appropriate location within the heritage precinct.
4. When relocating the scarred tree, consideration should be given to the scar being sheltered from the prevailing elements. This will mean placing it under some form of cover.
5. As part of the relocation process, the scar should also be treated for insect infestation and dry rot.

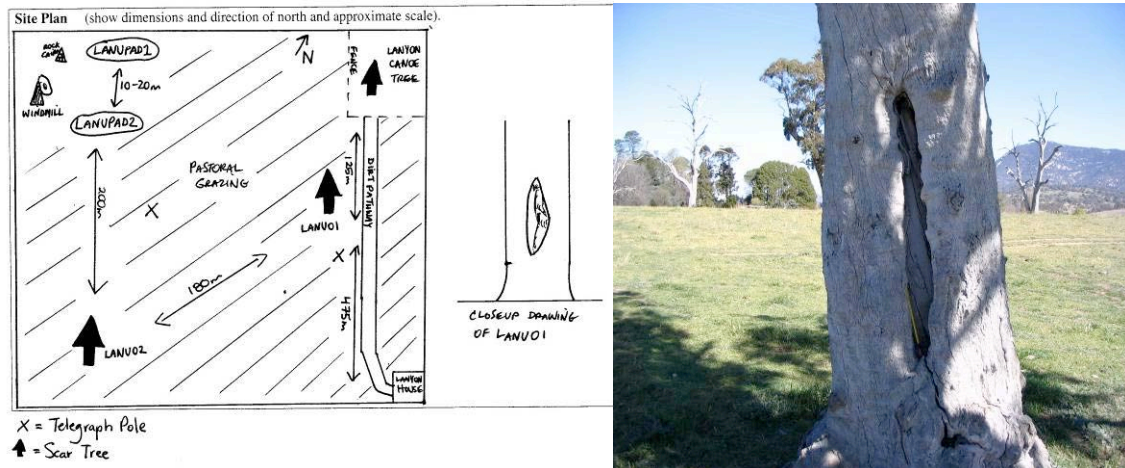
Canoe Tree. The tree is found within a large, undulating grazing paddock. The surface visibility around the tree is 10-20% with grass cover and some erosion patches. The offsite visibility is nil. The tree is a Eucalypt, but is dead so it is difficult to estimate the species and the age, but it must be at least 250-300 years old. The tree is in poor condition and is beginning to hollow out at the top end of the tree. The height of the tree is approximately 18-20 metres, with a circumference of 3.33 metres. The height of the scar above the ground is 85 cm and the scar faces away from the Murrumbidgee River in a northeast direction. The scar's length is 124 cm, the width in the middle is 15 cm and the depth of the regrowth is 14 cm. There are no axe marks visible. No artefacts were found near the tree and the potential for any is low.

Figure 97. LANTON01 – mud map, close-up drawing and picture of scar

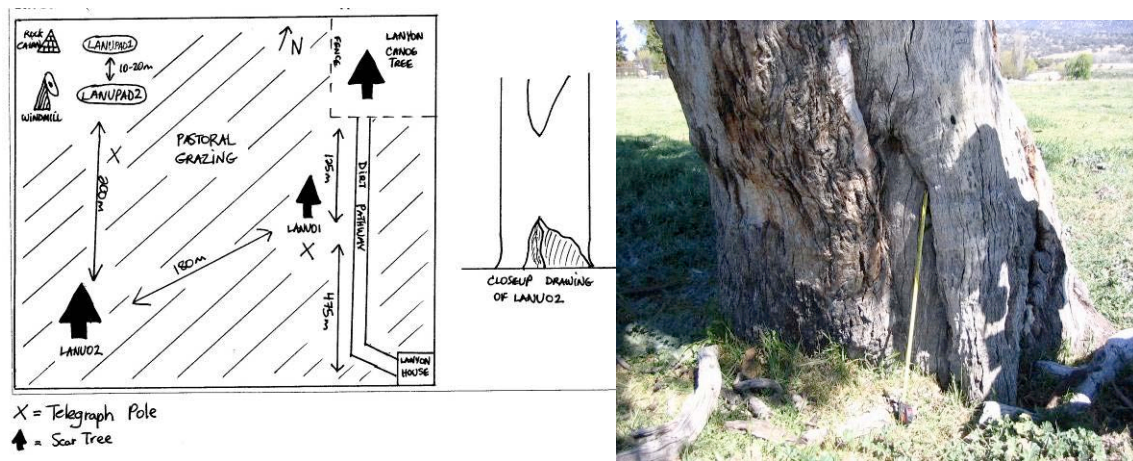
The site designated LANU02 is a scarred tree located 250 metres north-west of Lanyon Homestead, 275 metres east of the Murrumbidgee River and 175-200 metres from LANUPAD01 & LANUPAD02. The tree is found within a large, undulating grazing paddock. The surface visibility around the tree is 0-10% with grass cover the main reason. The offsite visibility is nil. The tree is a Eucalypt, but exact species is unknown. The tree is alive and the age is about 300 years old. The tree is in good condition and is approximately 15-18 metres tall. The circumference is 3.8 metres. The scar is at ground level creating doubt as to its authenticity. The scar faces away from the Murrumbidgee River in an easterly direction. The scar's length is 78 cm, the width in the middle is 16 cm and the depth of the regrowth is 15 cm. There are no axe marks visible. No artefacts were found near the tree and the potential for any is low. This tree was recorded at the request of traditional owner Don Bell, who felt that the bark was most likely used as a Coolamon to carry babies. I have reservations about the authenticity of this scar because (1) it is at ground level and different to the other two scar trees nearby, (2) this particular scar comes off of another more natural looking scar, (3) there is evidence of smooth rubbing at the top of the natural scar at a height that makes it likely to have been caused by cattle rubbing against the tree.

Figure 98. LANYU2 – mud map, close-up drawing and picture of scar

The authenticity of this being a scarred tree is highly questionable. It is the opinion of the consultant that the scar on this tree is of natural origins. On this basis it is recommended that there are no further archaeological requirements for this tree.

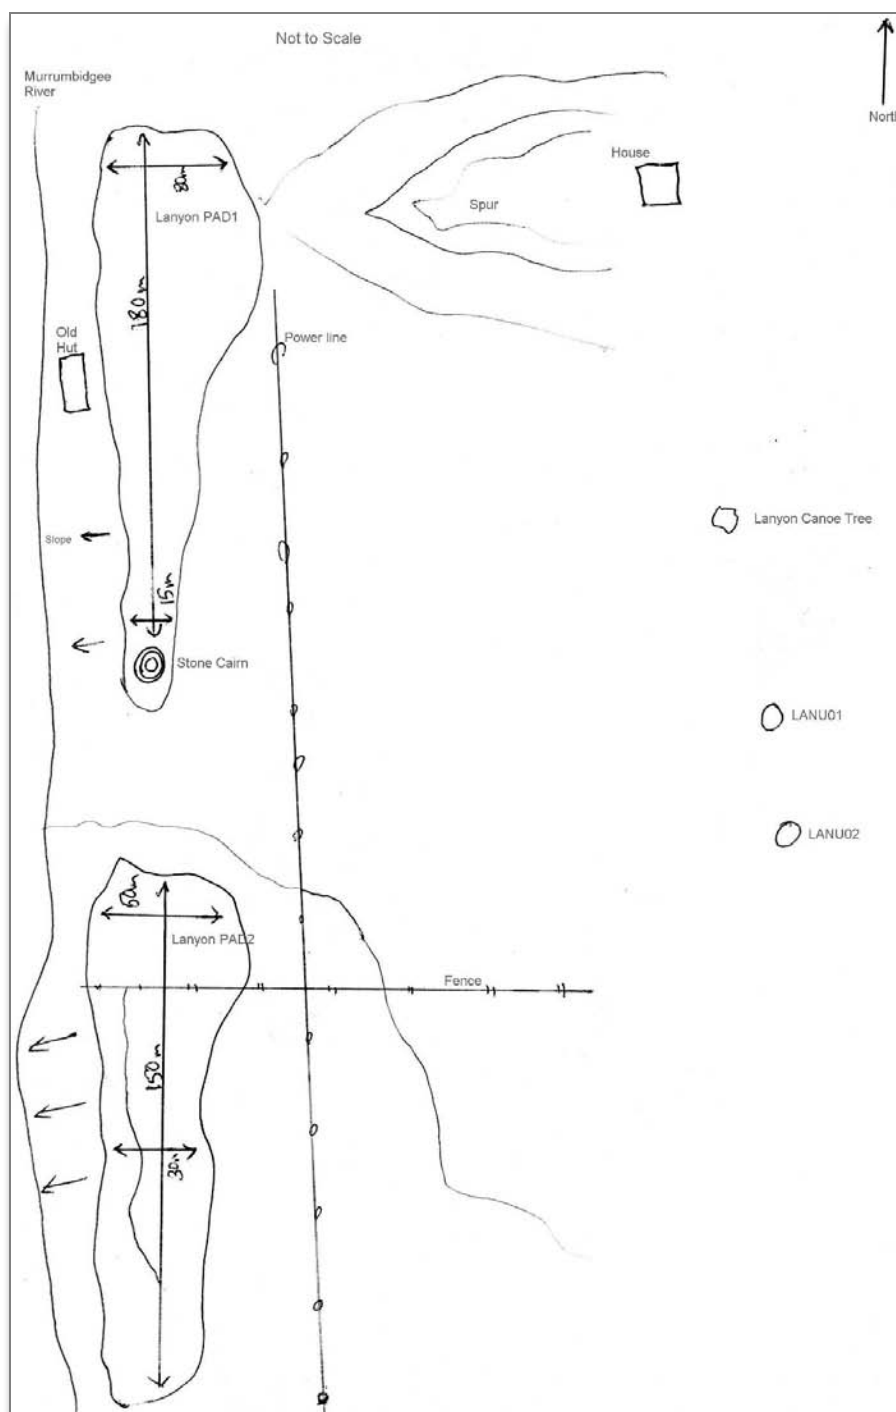
**Figure 99. Mud Map for Lanyon PAD1 and PAD2**

PAD. It is anticipated that high densities of sub-surface artefacts will be present within the identified bounds of the PAD. In light of the deep soil deposits present on the terrace, it could be reasonably anticipated that sub-surface artefact deposits will be extensive and potentially stratified.

3. The archaeological investigations should take the form of a program of sub-surface test pitting.
4. A series of 50 x 50 cm test pits should be excavated within each of these PAD areas. The number of test pits excavated at each PAD should be determined in consultation with the ACT Heritage and the RAOs, but as a minimum it is recommended that 20 pits are excavated at each PAD.
