DRAFT MUGGA MUGGA CONSERVATION AND MANAGEMENT PLAN

Volume 1

Prepared by

**Eric Martin and Associates
Geoffrey Britton
Dr Sandy Blair**

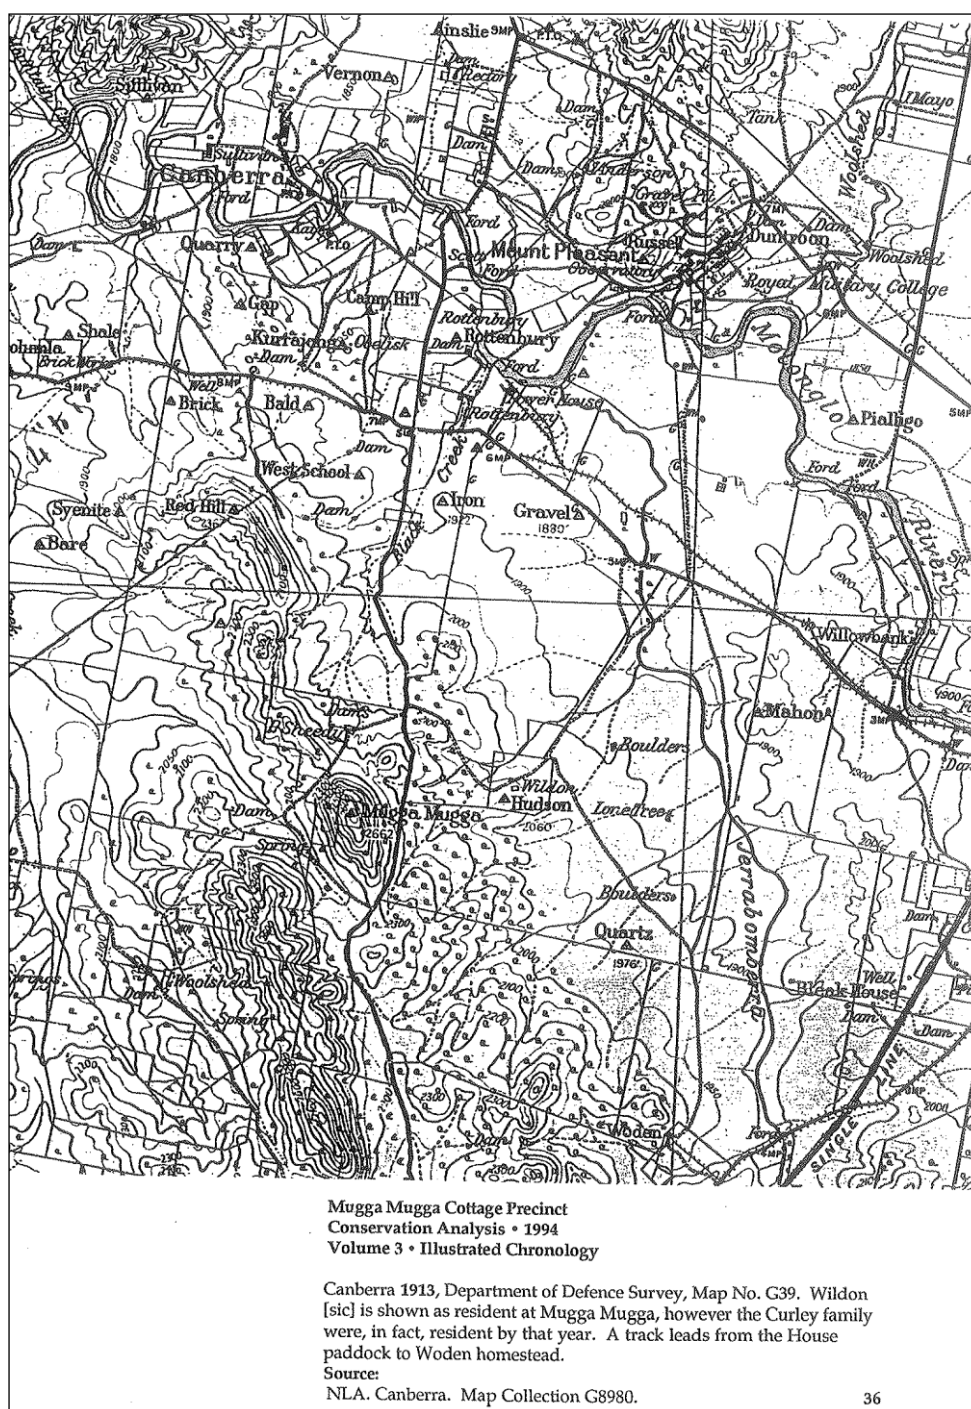
Figure 13: 1913 Department of Defence Survey, Map No G39.

The distinctive square house/horse paddock and its attached cultivation paddock are again confirmed on this plan along with key topographic features and access tracks, including those to Woden homestead, Duntroon homestead and Queanbeyan. Particular features are also noted on this plan, some of which fall within areas currently undeveloped such that they may still remain. Along with part of the access track to Woden homestead, possible extant features noted on the plan may include a “quartz” hill and distinctive groups of “boulders” to the east and southeast.

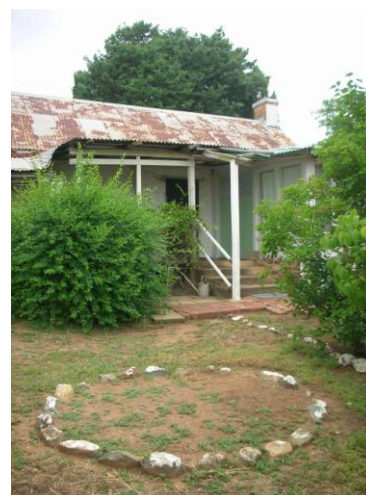
Figure 15: Detailed view of front garden showing an old *Jasminum mesnyi* in front of the much-amended cottage verandah and a vacant stone-edged ornamental bed.

- The simple orthogonal and symmetrical layout represents a typical early cottage garden form;
- Other species noted include “Honeysuckle” (elsewhere Ms Curley notes this as climbing honeysuckle so possibly *Lonicera japonica*) – one Jasmine (*Jasminum mesnyi*) of unknown age remains at the southeastern verandah (refer Figure 15) and Geraniums (within a narrow bed along the edge of the verandah);

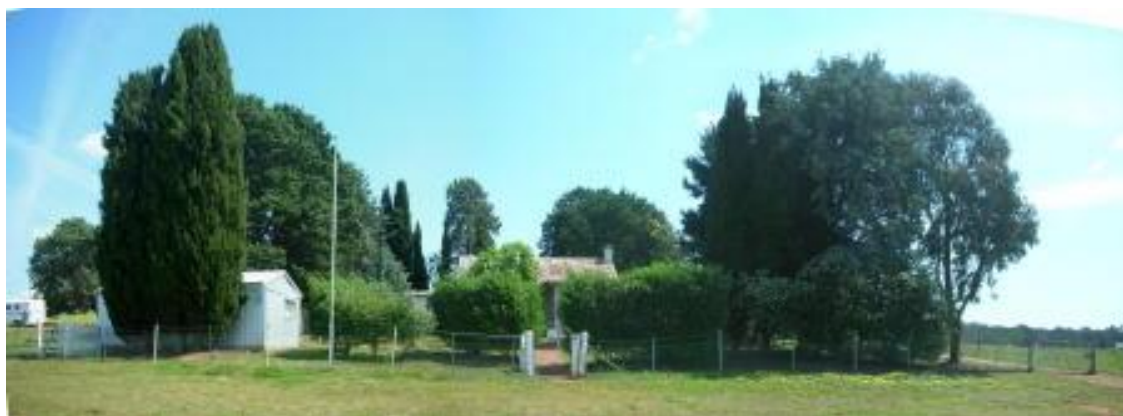
Figure 24: Cottage group from the front where the enclosing cypresses dominate the composition and the Tree Lucerne hedges form a screen for the front cottage elevation. Note also the Desert Cypress to the extreme left that has since been removed.

Mugga Mugga Cottage and its associated outbuildings form a small, compact farm group punctuated by an enclosing rectangle of mature cypresses. In the context of Canberra this is now a rare occurrence (refer Figures 24-27). Yet, the present general context of the Mugga Mugga Cottage Group is also remarkable for the 21st century as it is unusual for such a generous area of rural landscape - unencumbered by urban development - to remain around it. The cleared, open paddocks around the Cottage Group provide an essential traditional setting and serve to emphasise the dense cluster of plantings immediately enclosing the farm buildings – also a traditional characteristic.

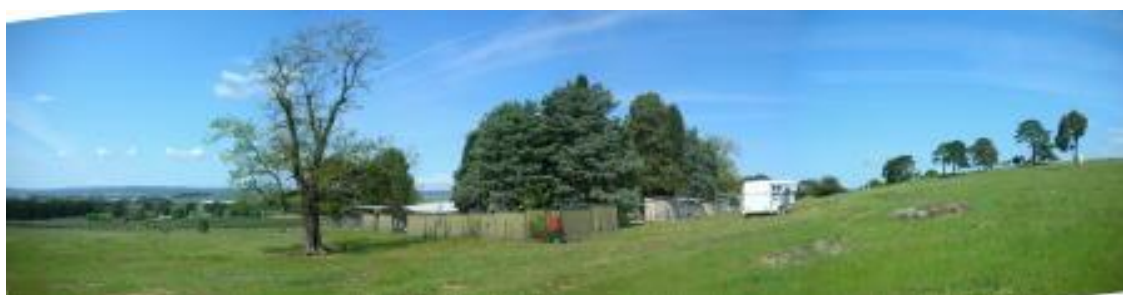
Figure 27: View from the west showing the 1985 metal panel fence around the 'service corner' of the cottage group. Note also the granodiorite rock outcrops to the right and the line of Monterey Pines along the southern boundary behind the horse trailer.

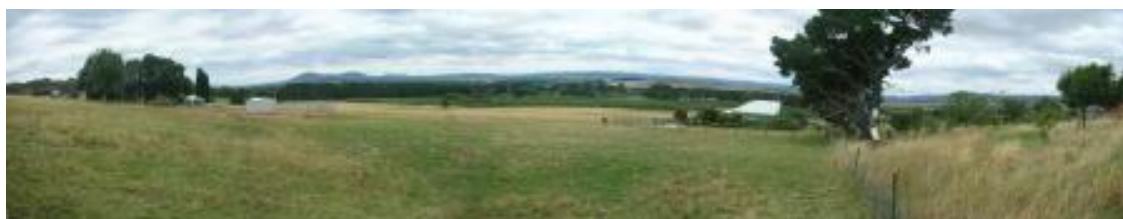
Figure 28: Panoramic view out from the site to the eastern ranges with Mount Majura and Mount Ainslie prominent to the north. The line of remnant pine plantings is visible to the right along the present southern site

The traditional open landscape also enables extensive views out from the cottage group to various distinctive landmarks such as Mount Hudson and Mugga Mugga close by and, further afield, Mount Pleasant, Mount Ainslie, Mount Majura and, to the southeast, Jerrabomberra Mountain. A direct sightline is also maintained between the Mugga Mugga site and its former estate core, Duntroon. Panoramic views across the Molonglo floodplain were likely even more extensive before recent shelterbelt plantings and various other scattered plantings obscured the views (refer Figures 28 & 29).

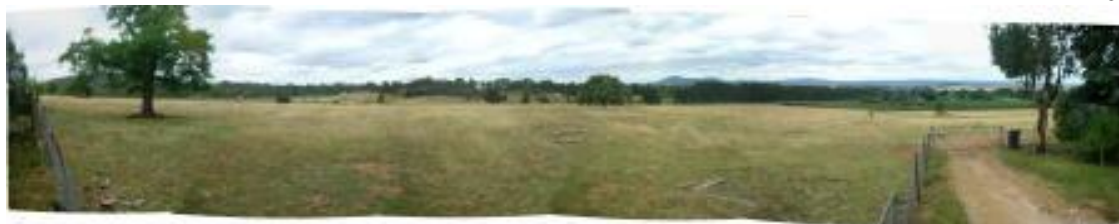
Figure 29: A northern panorama showing the traditional grassland setting of the cottage group and the relative lack of intrusion of adjacent residential areas although some development at the edges of Red Hill is just visible. The olive grove in the middleground to the right will remain low enough not to be intrusive, however the pine windbreaks beyond have already obscured important traditional visual connexions between Duntroon and the cottage group. The Red Hill ridge is visible behind the Black Locust to the left.

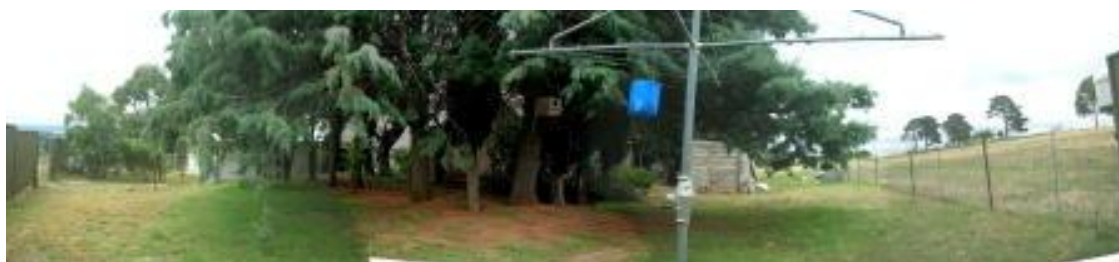
Figure 30: Panoramic view across the 'service court' behind the 1940s additions. The tight lines of cypresses probably indicate the alignment of earlier fences enclosing the plantings.

Part of the rationale for siting the early Mugga Mugga buildings seems to have been to exploit this scenic prospect by addressing both the Molonglo River floodplain and the former Duntroon estate core. The positioning of the cottage group on elevated land though just below the hill top seems to have been a deliberate attempt to seek shelter from the winter westerlies – the later planting of a dense line of conifers would have further reinforced this sensible strategy (refer Figures 30 & 31).

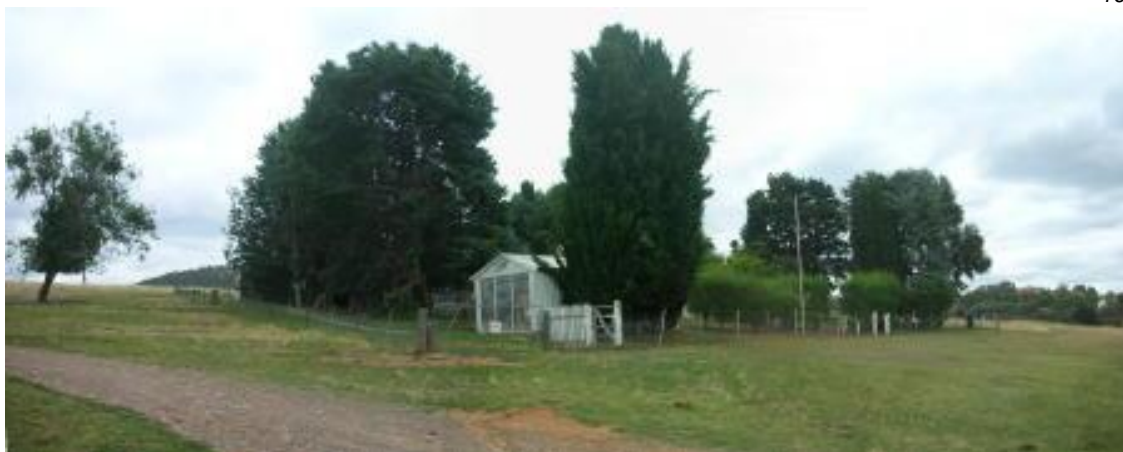
Figure 31: Cottage group from the east showing, behind the Roman Cypresses, the 1980s interpretive shed that replaced the interwar period motor garage. The short section of picket fencing and timber gate next to the shed preserves an earlier fence alignment shown on the c1960 site survey. Mount Mugga Mugga is visible in the background to the left.

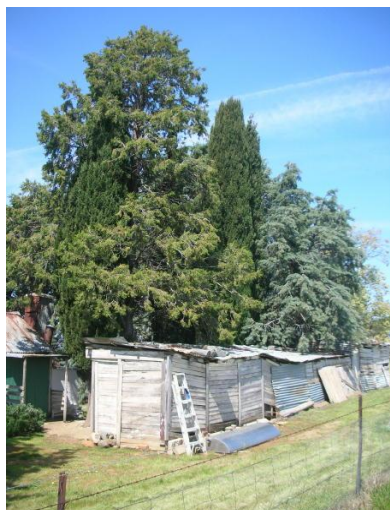
Figure 32: Unidentified cypress species behind kitchen block, possibly Mexican Cypress (*Cupressus lusitanica*) which appears on the Yarralumla Nursery's 1925 species list but under three other names (not *C. lusitanica*).

There are various older plantings remaining at the site and at the immediate southern boundary. In close proximity to the cottage group are several cypress species (*Cupressus arizonica*, *C. sempervirens* and a much more unusual species, possibly *C. lusitanica*) (refer Figure 32). Black Locust (*Robinia pseudoacacia*) (refer Figure 33). English Elm (*Ulmus procera*) (refer Figure 34). Tree Lucerne (*Chamaecytisus palmensis*) (refer Figure 35). and Lilac (*Syringia vulgaris* cv.) (refer Figure 35). To the south of the cottage group is a similar-aged Monterey Cypress (*Cupressus macrocarpa*) (refer Figure 36) and Monterey Pines (*Pinus radiata*).

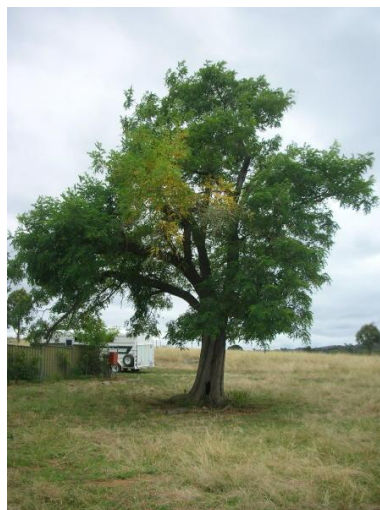
Figure 33: Old Black Locust (*Robinia pseudoacacia*) near location of early access track and former outbuildings. Various old concrete footings remain in the vicinity of the tree.

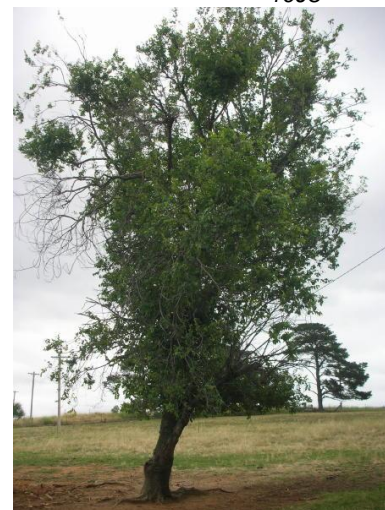
Figure 34: English Elm (*Ulmus procera*) struggling in the harsh conditions but marking the location of the former dairy.

Ms Curley noted that the surviving English Elm (*Ulmus procera*) to the south of the cottage group (in the vicinity of the former dairy) was planted by her parents and, on this basis, the tree would have been received from the Yarralumla Nursery. The Monterey Cypress (*Cupressus macrocarpa*) and the row of senescent Monterey Pine (*Pinus radiata*) at the southern site boundary may be from the same source as these species are listed as being available at Yarralumla Nursery by 1925.

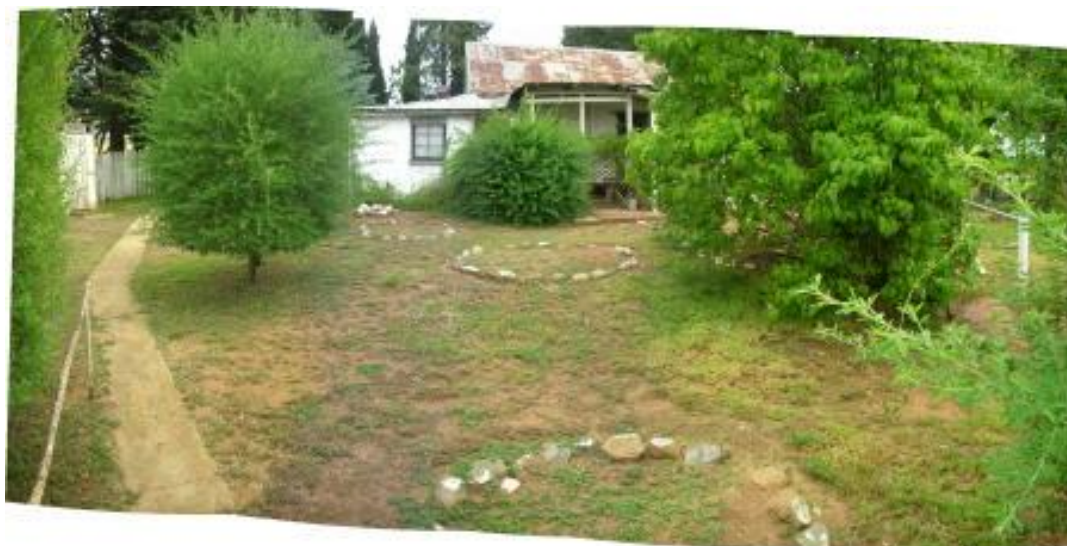
Figure 35: Detailed view of the front cottage garden on the southern side showing the field stone-edged beds, the old lilac to the right, Tree Lucerne hedges and the narrow curvilinear path with its fine water pipe handrail.

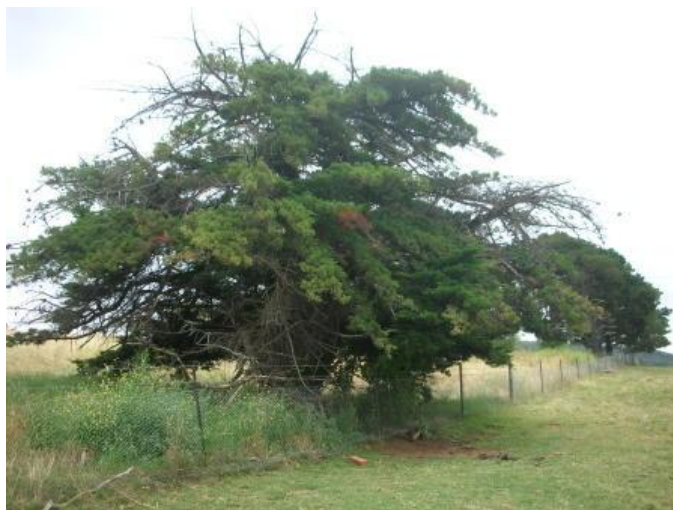
Figure 36: Senescent Monterey Cypress (*Cupressus macrocarpa*) at the southern site boundary.

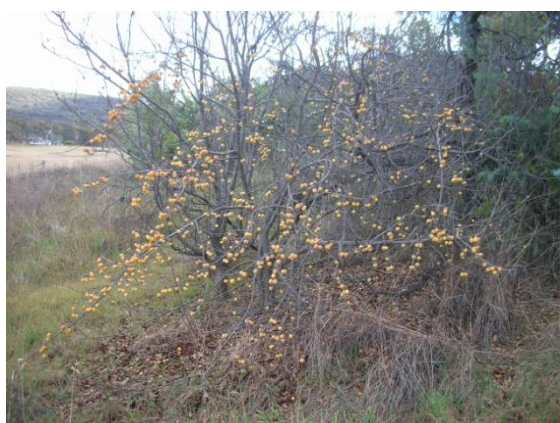
Figure 37: *Prunus* sp. (Plum) in fruit near the former vegetable garden site to the south of Hindmarsh Drive.

Just to the south of Hindmarsh Drive there appears to be the remains of the former vegetable site as various seedlings of two *Prunus* species persist in only this location (refer Figure 37). Nearby – at the point where the western creek descends into a culvert under Hindmarsh Drive – there several Weeping Willows (*Salix babylonica*) (refer Figure 38). Further along the creek, and on the cottage side, is a well site currently enclosed by mesh fencing. The well is defined by fieldstone and has a tripod windlass erected over it.

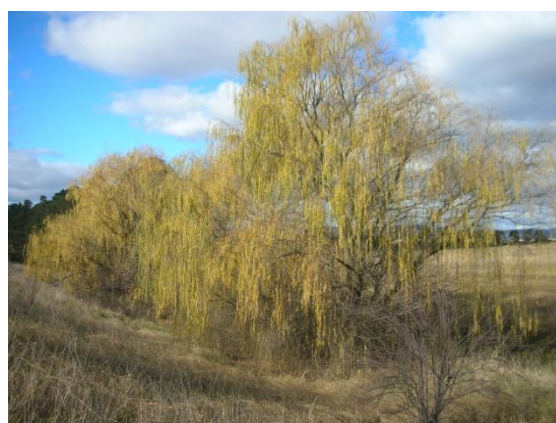
Figure 38: Weeping Willow (*Salix babylonica*) group to the immediate south of Hindmarsh Drive.

Further downstream of the creek and immediately to the south of the Hindmarsh Drive embankment is a line of Weeping Willows (*Salix babylonica*) with several trees demonstrating a few decades' age. Ms Curley noted that several old willows were located in this vicinity but removed with the construction of Hindmarsh Drive.

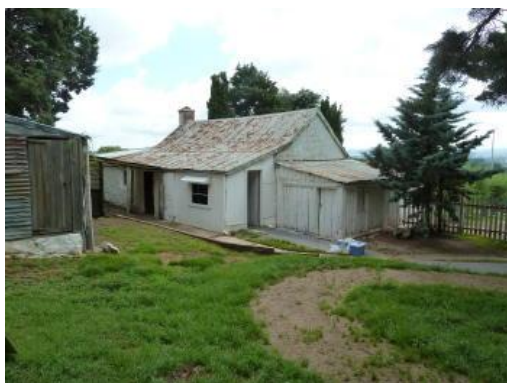
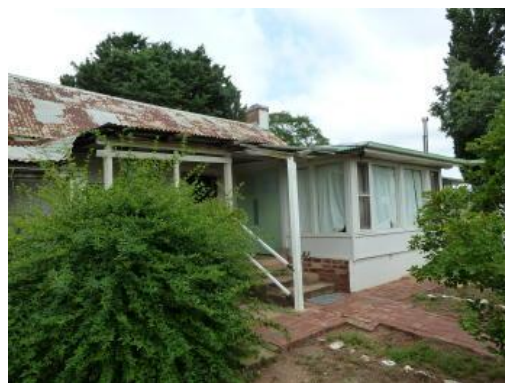
Figure 41: Cottage from South West

Figure 42: Cottage from South East

The roof is lined with corrugated metal with gable form over the main stone section and skillion roof over the other sections. The father's room has pit sawn battens and split timbers to roof and the main house has some sawn rafters. The stone walls have brick gable ends. The top plate is below the springing point of the ceiling.

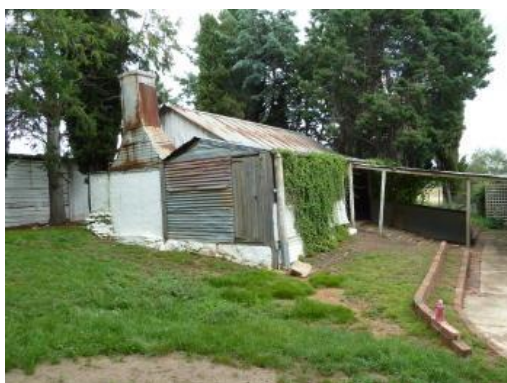
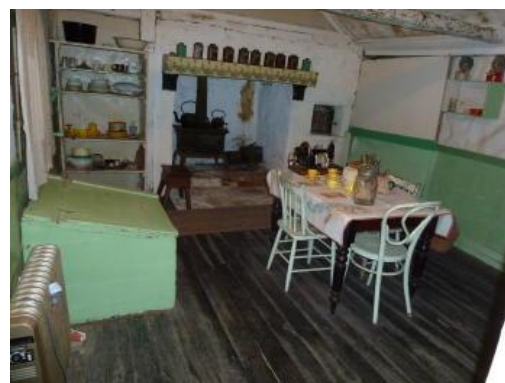
Figure 43: Kitchen from North West

Figure 44: Kitchen Interior

Internally the walls are painted, the Kitchen ceiling is tar papered and the dining area hessian. The floors are timber and doors and windows are timber framed.

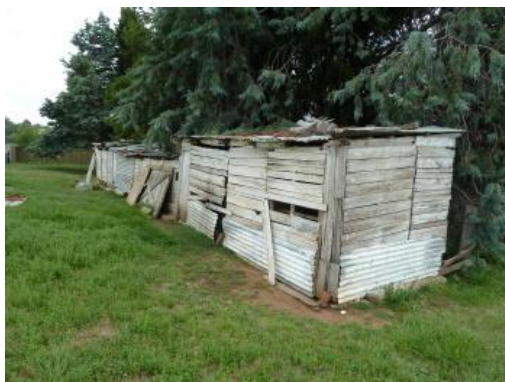
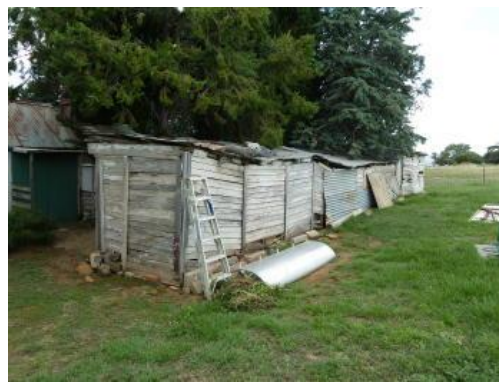
Figure 45: Shed from South West

Figure 46: Shed from North West

This is a long timber shed with skillion corrugated iron roof. It is divided into sections for feed store, general store and chook shed. Its improvised and rustic condition has evolved to meet Curley's requirements.

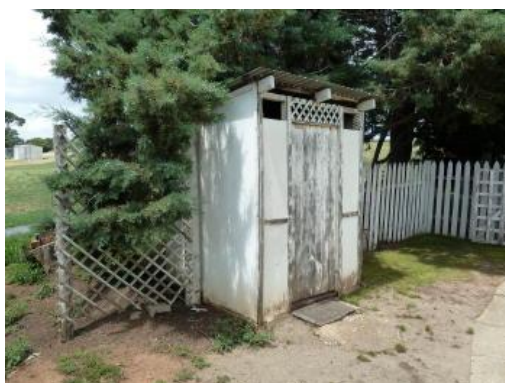
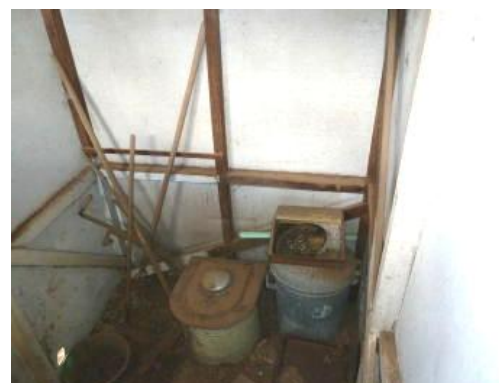
Figure 47: Toilet Exterior

Figure 48: Toilet Interior

A small fibro clad timber framed freestanding toilet with a corrugated iron skillion roof.

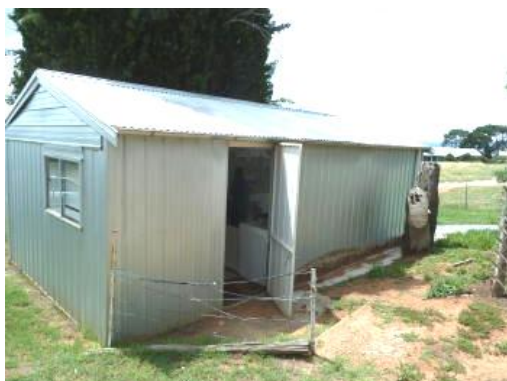
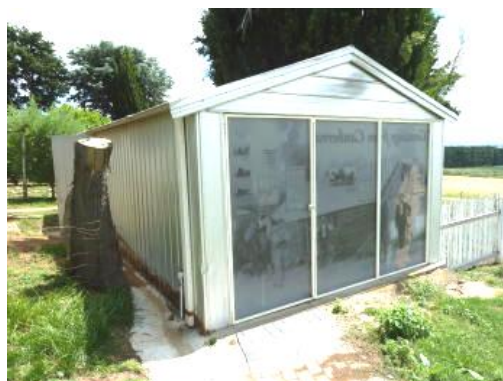
Figure 49: Garage from North West

Figure 50: Garage from South West

A standard metal clad garage with metal gable roof which replaced an earlier garage on the site. The floor is concrete and is now used for interpretation and displays.

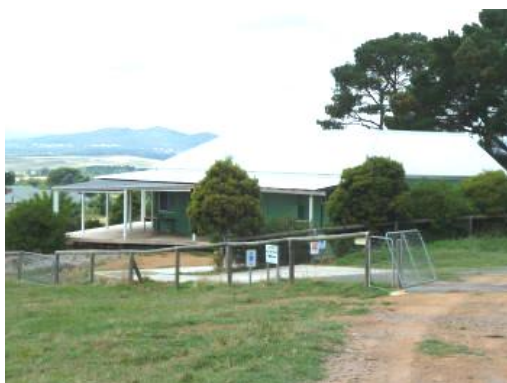
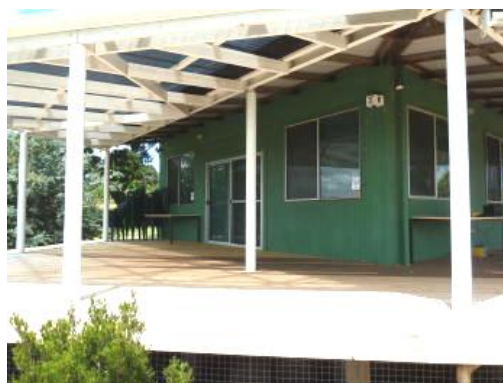
Figure 51: Education Centre

Figure 52: Education Centre from Deck

Internally floors are timber and walls are lined with plasterboard. The building includes a large room, kitchen and toilet.

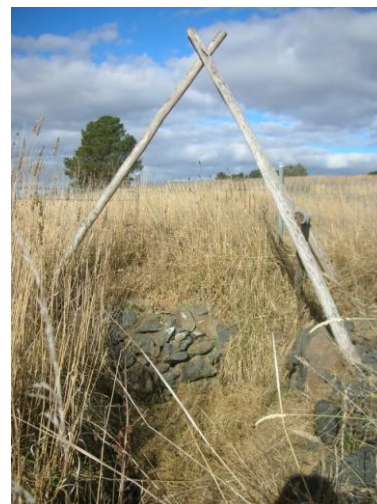
Figure 54: Well site at creek to the west of the cottage group. Note the use of field stones to form the well access.

The old well site remains along the creek to the south of Hindmarsh Drive within a small fenced enclosure (refer Figure 54). Stone lining the upper well has been repaired in recent years and, for safety reasons, a galvanised mesh fence has been erected around the site. A timber tripod windlass has been installed to interpret the former use of the feature as a vital source of water. Both the well and the adjacent former vegetable garden are noted in Sylvia Curley's accounts as having origins before her family moved to live at Mugga Mugga in 1913.

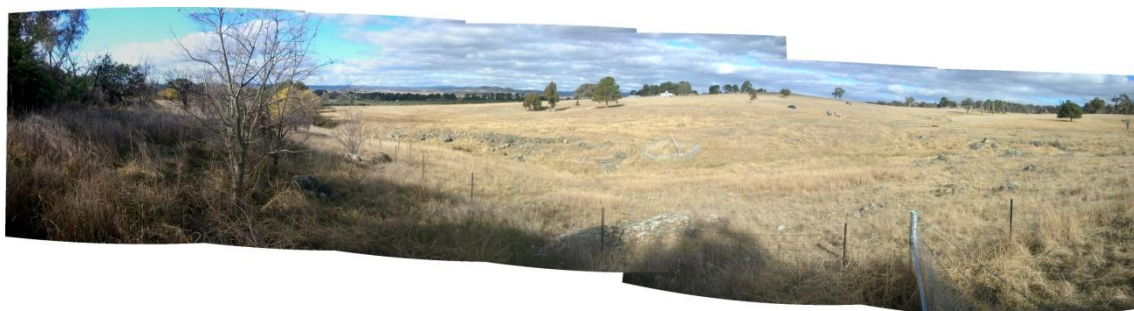
Figure 55: Panoramic view including the former vegetable garden site across the slope to the left, willows (in yellow leaf) beyond, well site with enclosing mesh fence and tripod windlass in middle with cottage behind in the distance and the Mount Hudson trig station at the crest.

Evidence of the former vegetable garden remains nearby on the opposite side of the creek and just to the south of Hindmarsh Drive (Refer Figure 55). Seedlings of two fruiting trees – both *Prunus* spp. with one in small yellow fruit in June – remain within this area although no evidence was found of the quinces that Ms Curley described. Several bushes of a profusely red-hepped, deciduous *Rosa* sp. are also present within this area as are two *Celtis* sp. seedlings.

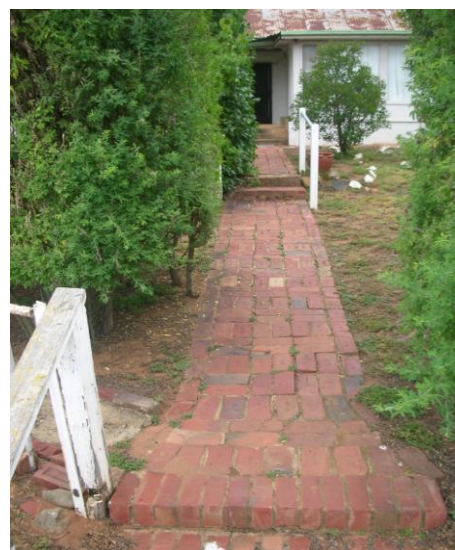
Figure 56: Main front entry path with framing tree lucerne hedging.

The oral record also indicates the basic front garden layout to the cottage as a simple symmetrical arrangement (confirmed by the 1912 Percival survey) with a central path, extending the main house axis, to a small front gate. This was a formula that appeared in countless layouts for many 19th century cottages and unpretentious homesteads across Australia. Although the brick surfacing was introduced in the 1940s, the existing front entry path preserves something of this early layout and, with evidence of level changes and, possibly, edging materials, some evidence of the former reduced extent of garden enclosure may remain (refer Figure 56).

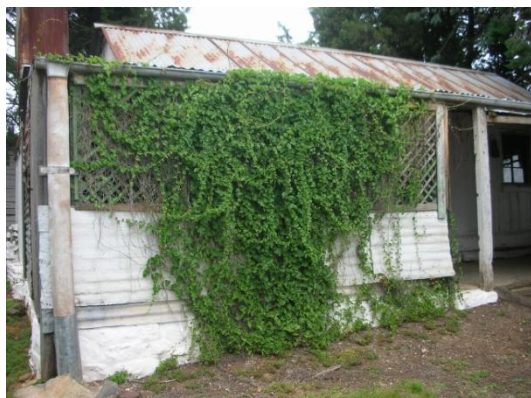
Figure 58: Madeira Vine (*Anredera cordifolia*) growing over the kitchen block verandah. This was introduced here by Annie Curley.

Sylvia Curley indicated that the Madeira Vine (*Anredera cordifolia*) or Potato Vine climber around the kitchen block was introduced by her mother during the interwar period (refer Figure 58). In a warmer, coastal climate this species would become a rampant and difficult plant but Canberra's winters probably keep its prolific tendencies in check. Other plantings known from the oral record to have been introduced in this period by Annie Elizabeth Curley are the rosemary (*Rosmarinus officinalis*) and lilac (possibly using a cutting from the old Duntroon-sourced plants at the front of the cottage) at the back door of the kitchen block.

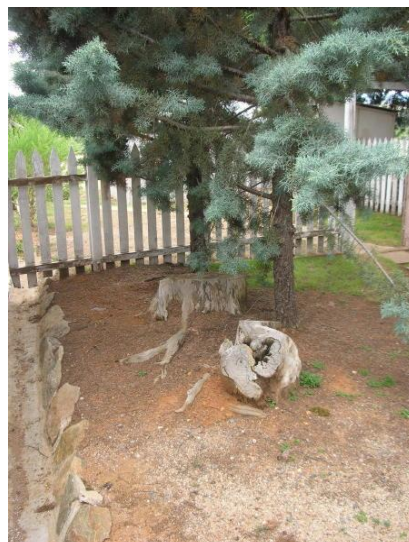
Figure 59: Old cypress stumps – presumably Desert Cypress (*Cupressus arizonica*) – and more recent replacements next to the cottage.

Two old tree stumps remain to the south of the cottage where (presumed) replacement trees (Desert Cypress) have been planted (refer Figure 59). A *Rhododendron* cultivar is within the modern bed in front of the 1949 cottage extension.

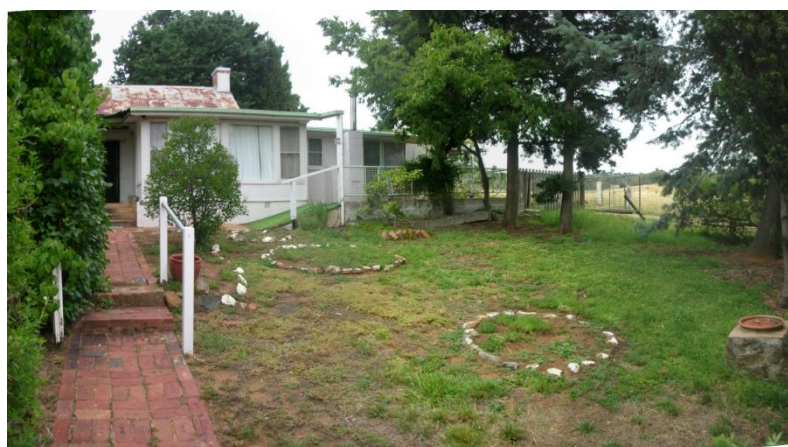
Figure 60: View of the cottage garden on the northern side with the main axial entry path to the left. The steps and handrail probably indicate the original extent of the garden enclosure based on the 1912 Percival survey.

Within the front garden there is an overlay of various phases of layout. Around the surviving early axial path and simple symmetrical layout there is a partly symmetrical arrangement of circular planting beds using white-painted fieldstones as edging (refer Figures 60 and 61).

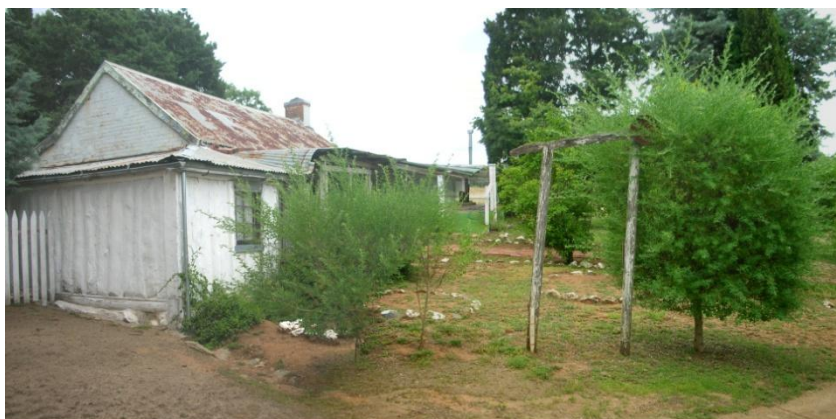
Figure 61: A further view of the southern cottage garden area showing the slab addition to the cottage and an earlier timber portal possibly indicating a former gate entry. The structure accords with where an earlier fence is shown on archival documents in line with the slab addition.

from Ms Curley's evidence, the interwar period would be consistent. Bedding along the 1949 extension is likely to have been added in about 1950 (refer Figures 61-63).

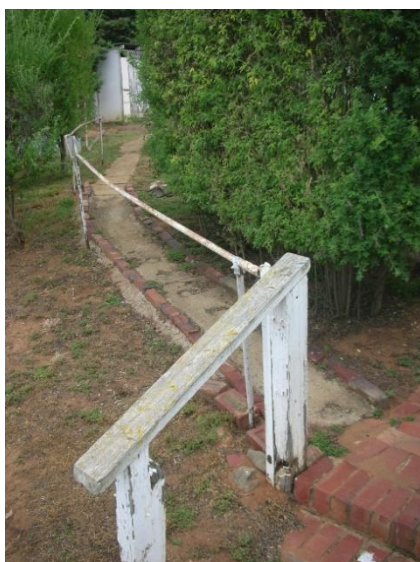
Figure 62: Front entry with 1982 side path and water pipe handrail, star picket and recycled timber posts demonstrating considerable resourcefulness in the adaptation of available farm materials for new uses.

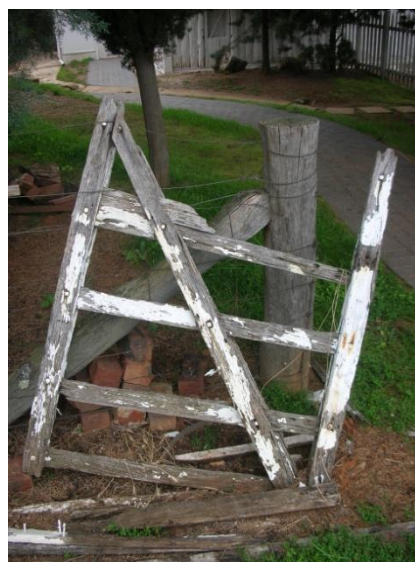
Figure 63: An earlier traditional timber gate.

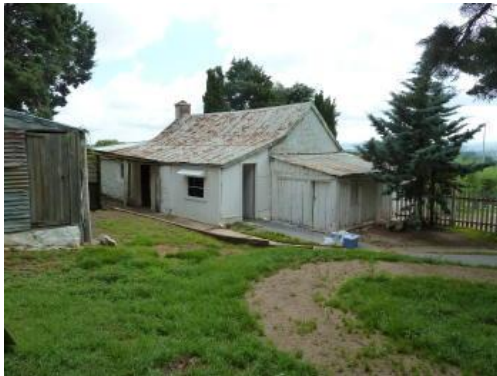
Figure 65: Mugga Mugga Cottage

Mugga Mugga is not a complete farm such as Lanyon, Tuggeranong or Horse Park but mainly a cottage as an outstation of a larger property (Duntroon). It is similar to Blundell's Cottage and Majura Cottage which were the other outstations to Duntroon constructed about the same time.

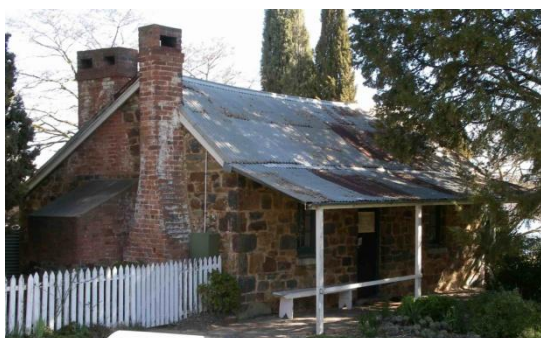
Figure 67: Blundell's Cottage

Blundell's Cottage (1858) has now lost its context and Majura Cottage (c1850) is still an active farm but dominated by additions and adjacent structures so its context has been compromised.

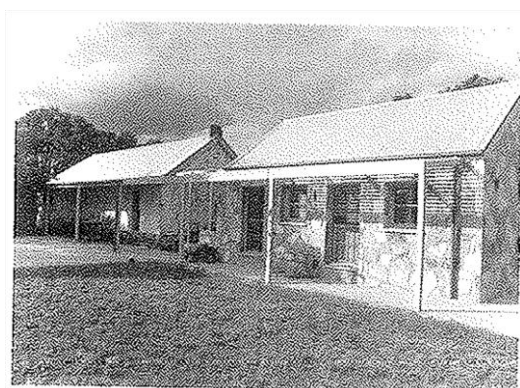
Figure 69: Majura Cottage

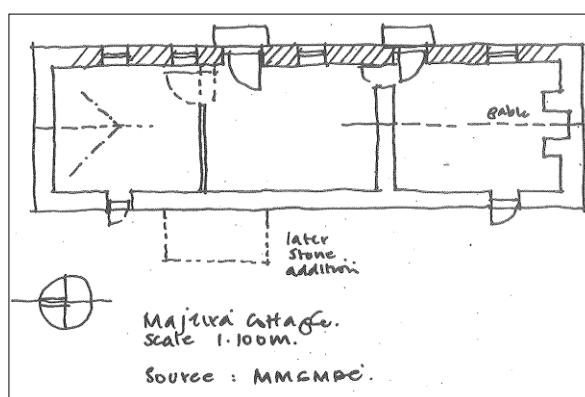
Figure 70: Majura Cottage Floor Plan

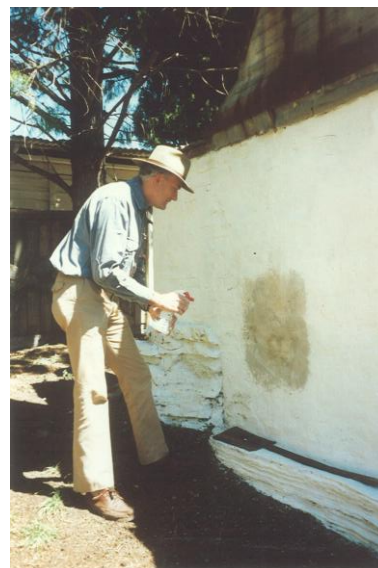
Figure 75: David Young pre-wetting the kitchen before applying limewash, 'Traditional Building Materials' University of Canberra Summer School at Mugga Mugga, 1995.

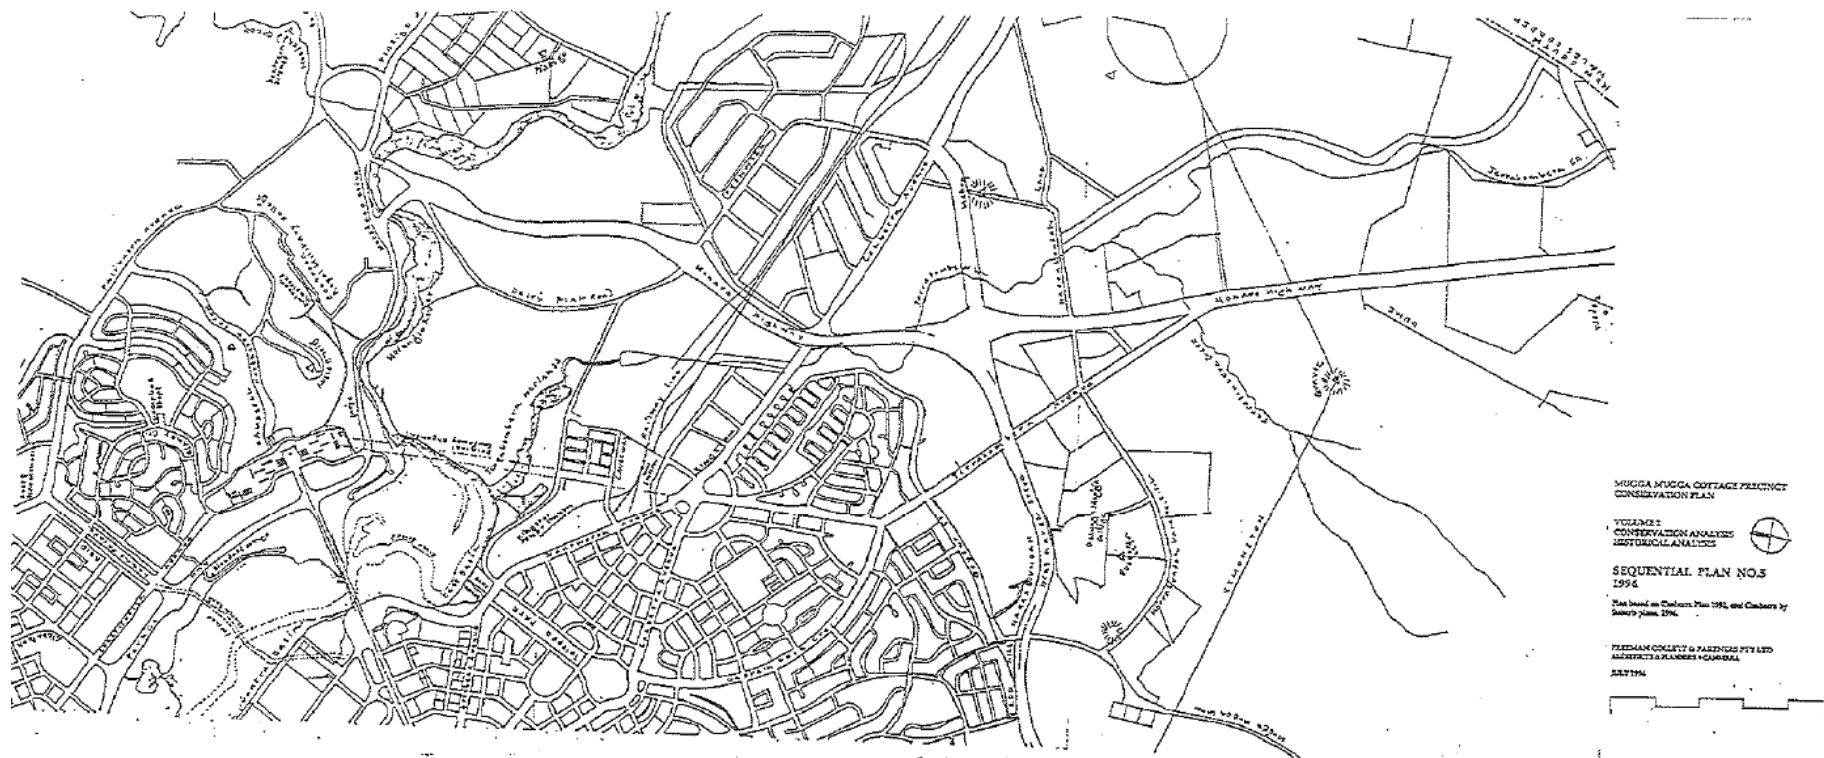
Conjectural Sequential Plan No 5 c1994

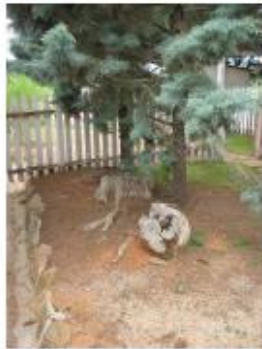
Old cypress stumps next to cottage

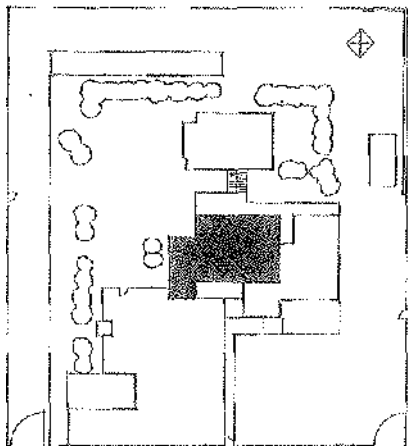
Figure 3:

The Cottage

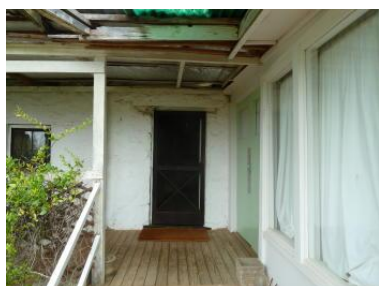
Figure 4: Front door with fly wire screen and raised timber porch

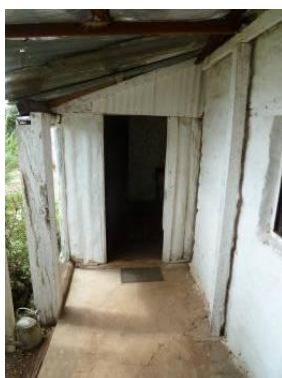
Figure 5: Front verandah view north to flat

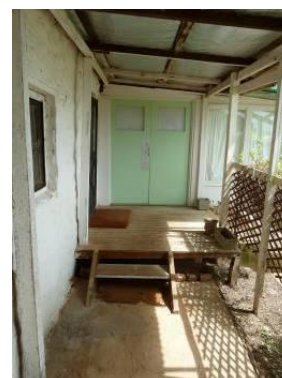
Figure 6: Front verandah view from south

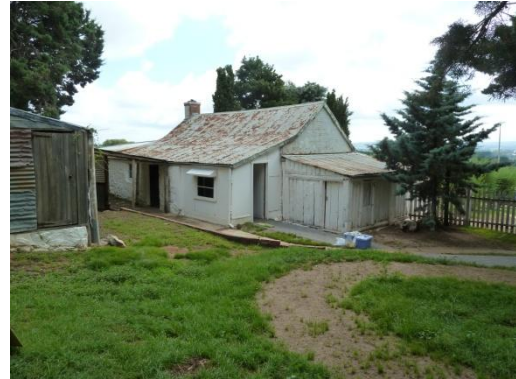
Figure 7:

At the south elevation the slab walled skillion abuts the south wall of the cottage where the patched brick gable sits upon the rubble-stone wall. On the western end of the gable, infill brickwork can be noted dating from the addition of the west skillion.

Fascias consist of sheet lead.
Analysis of the slab extension would suggest portions of an existing structure relocated to its present position

South west corner of Cottage with oblique view of south elevation

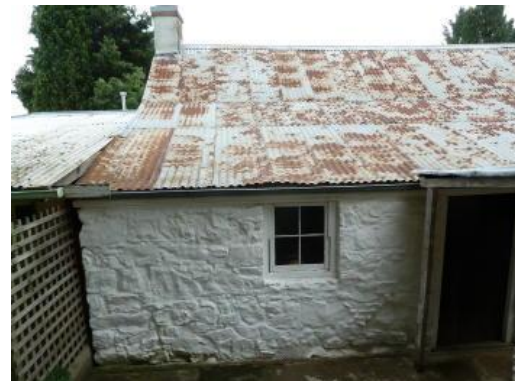
Figure 8:

The west elevation consists of a random rubble wall to the north end. To the south end, a sheet fibro wall replaces a section of rubble walling that collapsed some time ago. There is a centrally placed door and two windows to either side. Prior to the collapse of the wall, this facade would have been symmetrical. The stone work, which has been white washed.

The Cottage west elevation

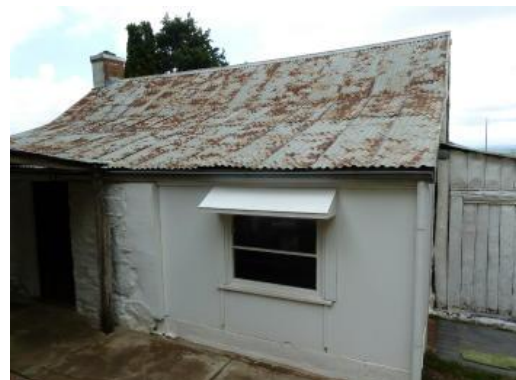
Figure 9:

The Cottage east elevation

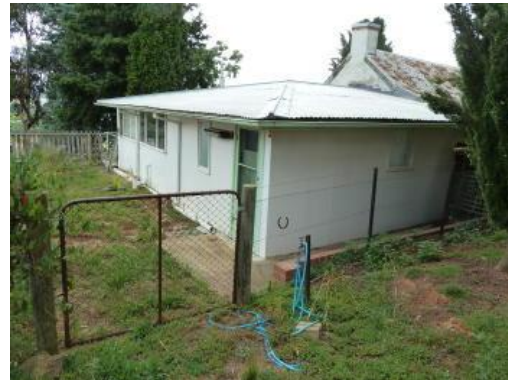
Figure 10:

The north elevation of the cottage was covered by the construction of a fibro and timber flat in 1949.

The flat has a lower pitched corrugated metal roof.

The top of the north wall can be seen above the flat in this view from the north.

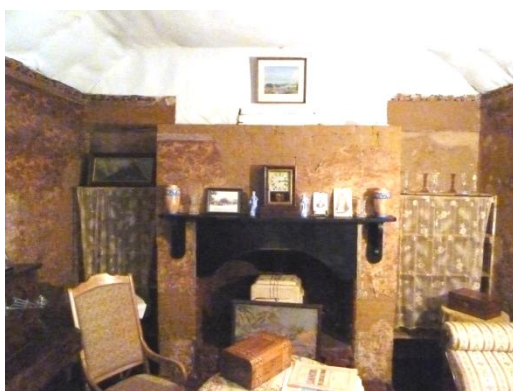
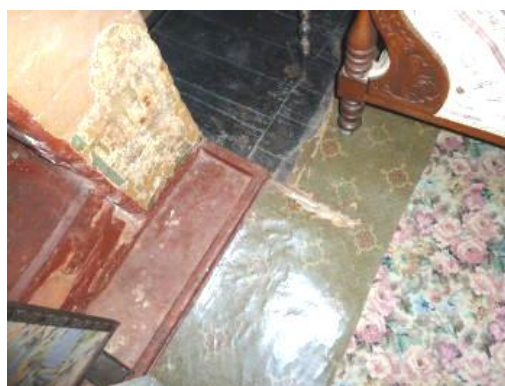
The brick fireplace appears to have been limewashed and subsequently papered. The base of the hearth has been raised by four bricks (now heavily fretting from rising damp) and is painted red-ochre colour. Splashes of the red paint are evident on top of the floor boards adjacent.

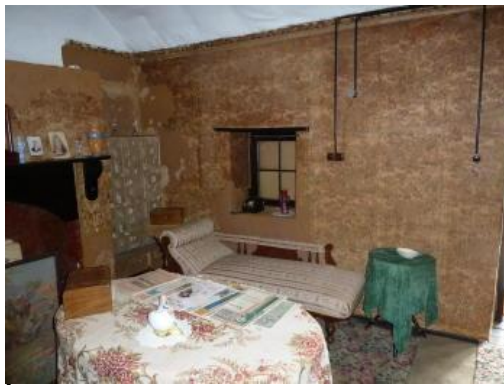
Figure 13:

At the top of the chimney breast the flue is stepped back to be integral with, but proud of, the gable wall. The top of the chimney breast is infilled with stone rubble. Above the chimney breast, but behind the hessian, the limewashed brick gable is apparent with a machined timber plate evident where the gable rises from the stonework. It is not clear if the gable is one course thick resting on the plate.

There is a brick flue above chimney breast.

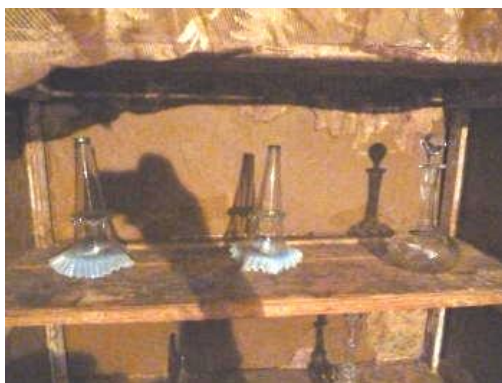
The shelves to either side of the chimney are fabricated from assorted pieces of timber, some machined and a few pit sawn. Construction is simple with the shelves built onto the wall and resting upon the skirtings. The shelves have been covered in newsprint as a base and the visible surfaces covered with the same wallpaper as elsewhere in the room. A date visible on the newsprint is *Monday February 16, 1931* (not seen in 2011). On the second shelf from the top is a small timber strip that was probably a plate restraint. The render behind the shelves is damaged in places consistent with objects impacting against the wall. In one location a large hole is filled with paper mache newsprint. Hooks at top and bottom of both units indicate curtains stretched as a cover to the faces. A lace curtain is now installed.

Figure 14:
Shelving Detail

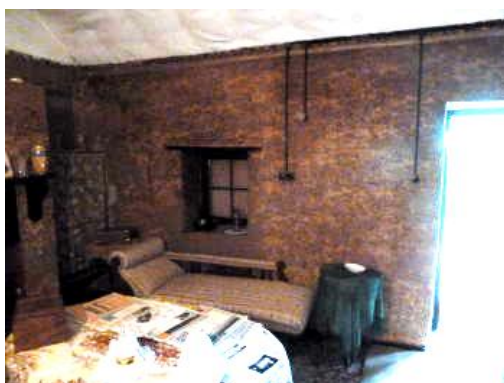
A granite rubble wall with the same finish sequence as for the north wall. The wall has been constructed to plate height (2.4m) with the space to the underside of rafters and shingles having been filled in with lath and cement plaster. The upper portion of the wall therefore appears firm. This differs from the construction sequence at the top of the north wall where the wall is extended in hessian on a timber frame.

The wall paper has been taken into the reveals around windows and doors. Construction details of the heads are hidden by the wallpaper. There is a large cement repair beneath the window. A mark on the wall adjacent to the shelving indicates an earlier shelf unit of the same height but protruding forward to line up with the front of the fireplace.

Figure 15:
Front Room East Wall

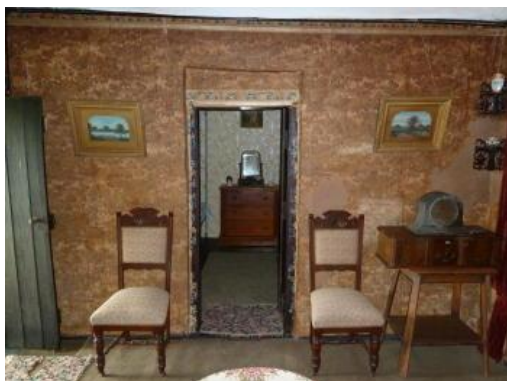
Figure 16:

Wall paper finish to cornice height (approx. 2.4) with white painted hessian to underside of tent. It is believed this wall is constructed of solid sandstock brickwork approx 230mm thick, with a lime render finish to both sides. The render is returned to meet the 150 mm x 70mm hardwood door jamb. There is a shallow reveal above the door to about 2.1m as if the jamb has been continued upwards. It is not known if the brickwork finishes at 2.1 height (as do the walls (not obvious in 2011 except in bedroom) and chimney breast) or continues to the cornice. That this is a brick wall is of some interest, as one would anticipate this wall to be of the same material as the external walls if constructed at the same time. However the wall may have been constructed to the earlier plate height and it is noted that brick is used extensively in the gables and chimney breast. Two conduits are mounted at cornice height.

South wall with view through to bedroom. Note door reveal and wallpaper boarder.

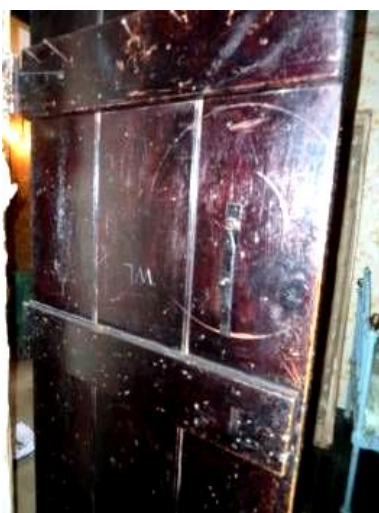
Figure 17:

There are three wide timber planks in the ledged and braced which is heavily marked. The door is fitted with a white ceramic knob. The initial 'A' carved into the door is upside down.

Door between front room and bedroom. The initial A is upside down beneath the handle.

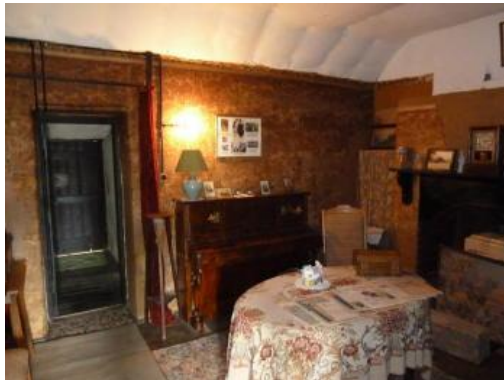
A bakelite switch and light are wall mounted. Two metal conduits then feed through the door jamb to the west of the building and the kitchen.

Figure 18:
Front room West Elevation

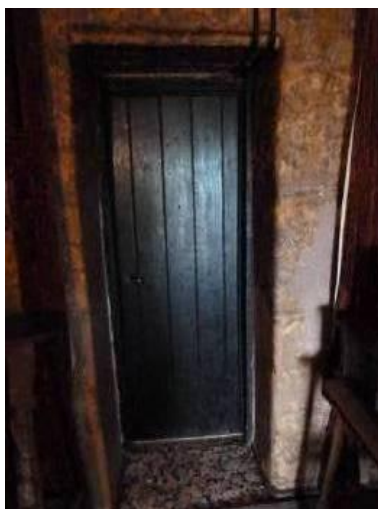
There are five vertical boards in the pine door with Japan finish set deep in the reveal. Head construction not known. Cement floor in doorway is presumably not original now covered in floral carpet. Damaged plaster to both sides of reveal show a limewash finish to the original granite stonework followed by two coats of render, layers of limewash and cement mortar patching beneath the wall paper. Cement patching is evident in several locations within the room and was obviously applied in preparation for the wall papering.

Figure 19:
West Elevation. Door through to hall.

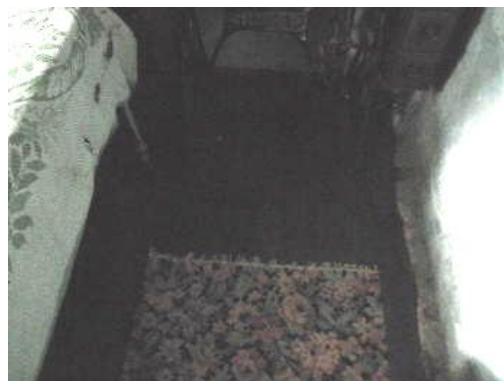
150 x 25 butt jointed hardwood with Japan finish to whole surface, now in reasonable condition. A patterned linoleum runner on paper backing is centrally to the room over which is placed a protective drab coloured mat.

Figure 21:
Bedroom Floor

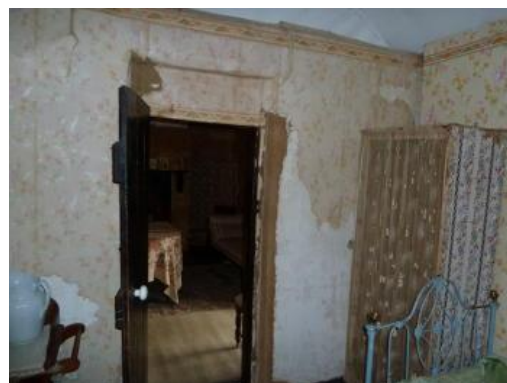
A rendered brick wall with several layers of limewash. A newspaper backing sheet *Sydney Morning Herald* October 1930, has been covered with the present wallpaper.

The wall appears solid to cornice height and is capped with a limewashed timber slab which has subsequently been wallpapered. Hessian continues to the underside of the ceiling on the front room side of the wall. The wall may have been constructed to 2.1m initially and extended to 2.4m prior to papering (which could explain the shallow reveals to the doorway).

Figure 22:
North Wall

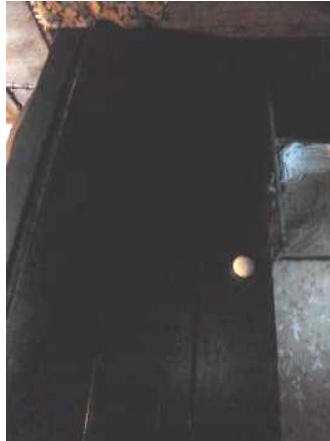
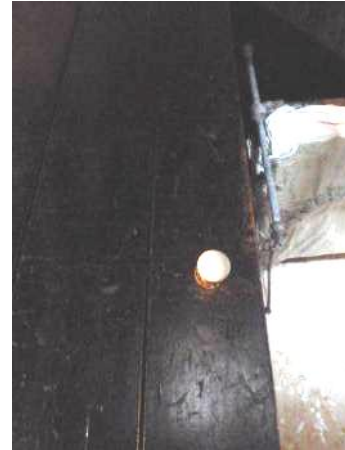
The heavily marked 3 panel ledged door to the front room appears to have been recycled. The initials WL are carved into the door but are upside down. A former lock hole is located lower down. A swivelling catch that still operates has worn several concentric circles into the woodwork. The T hinges are mounted on packing blocks.

Figure 23:
Bedroom side of door to front room.

Figure 24:
Bedroom side of door to front room.
Note scarring from catch and initials in central panel.
