DRAFT MUGGA MUGGA CONSERVATION AND MANAGEMENT PLAN

Volume 1

Prepared by

**Eric Martin and Associates
Geoffrey Britton
Dr Sandy Blair**

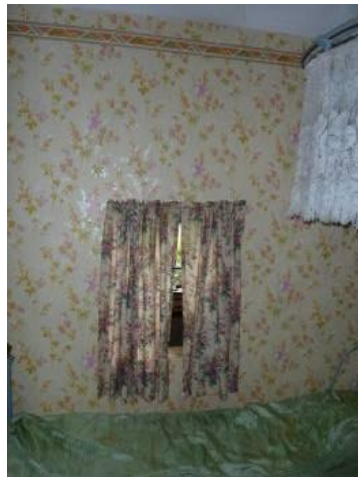
Masonry wall with two coats of render, layers of limewash and wallpaper. A four pane timber sash similar to the eastern parlour window is mounted in the deep reveal and the window now has a security reed switch. A hewn timber head supports masonry above the opening. The wall has been extended from plate height to cornice height. A vertical batten or lath is located within the render approx 900mm from the north corner. Both eastern windows (one in front room and one in bedroom) are symmetrical about the entrance door.

Figure 25:
East wall with false wall
inside original wall

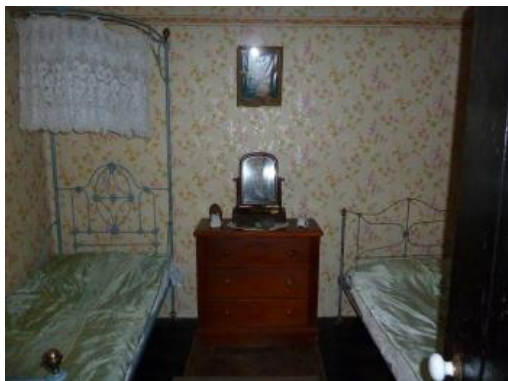
Masonry render and limewashed as elsewhere to a timber plate at 2.4m. Hessian continues to the underside of the ceiling, with wall-paper and border finishing at cornice height (2.4m).

Figure 26:
South Wall

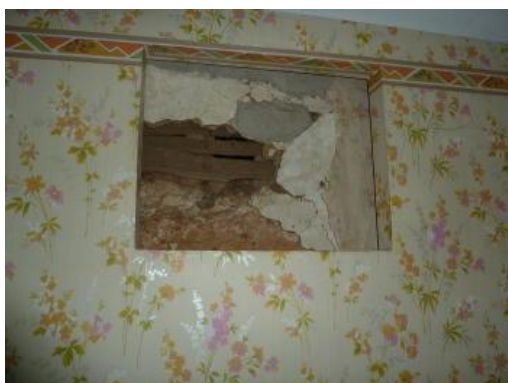
Figure 27:
West wall showing exposed lath work
behind false wall.

Masonry wall with render and limewash to 2.1m. The decayed plaster atop this wall reveals crude laths that appear to be pre-weathered hardwood roughly fixed to battens with forged nails. The wall paper extends across both sections of wall to 2.4m. A large section of render has fallen off the lower wall.

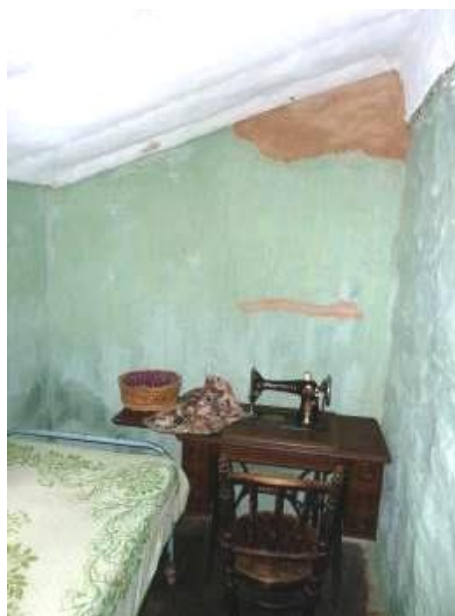
Figure 29:

Granite rubblestone with render now finished with green calsomine. The wall is rotating slightly to the north indicating a lack of integration with main building. Render on upper portion of wall (above 2.1 m) is bulging. Some render repairs, particularly at the top, have been left unpainted.

Bedroom 3, North view.

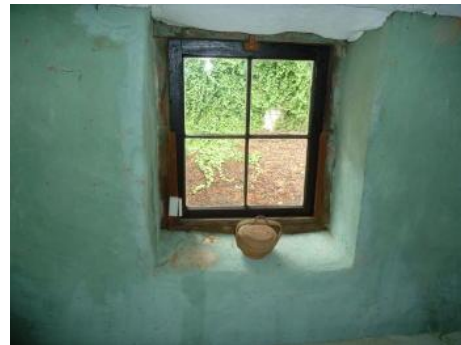
An external masonry wall rendered and now finished in green limewash contains an original four-pane window sash hung hopper style in a hardwood frame. The sill, which is weathered, shows wear and tear from animal entry and plant growth. Some new timber has been spliced into the frame which has tacks as if for curtains. A security reed switch has been installed on the window.

**Window in west wall. Four pane
hopper style.**

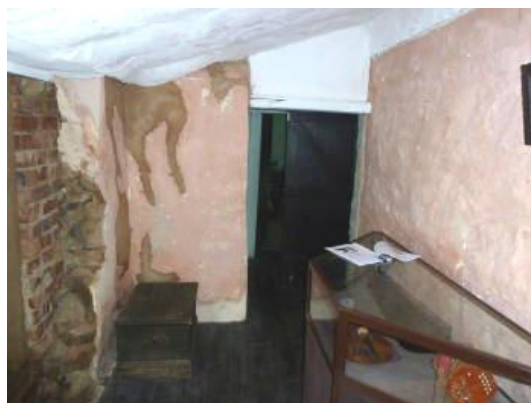
View north to lobby.

Note that door and jambs to lobby are missing. Textured wall on east is earlier external west wall. The former window reveal is evident in upper left corner.

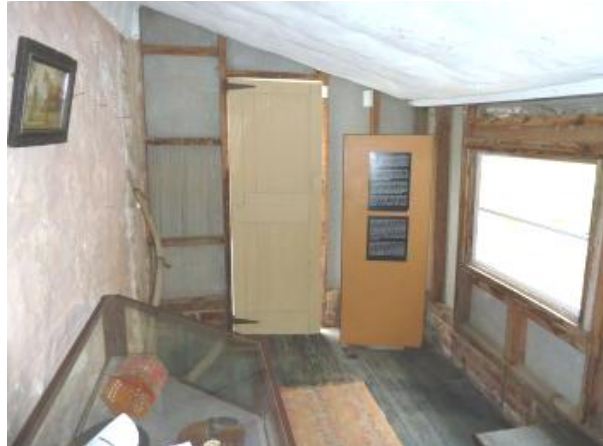
A timber stud wall with fibro (asbestos cement sheeting) to outside skin. The wall is constructed on a dwarf brick wall and has a recycled timber framed and vertical boarded door hung centrally. A security reed switch has been added to the door.

Figure 36:
View south showing
introduced fibro wall

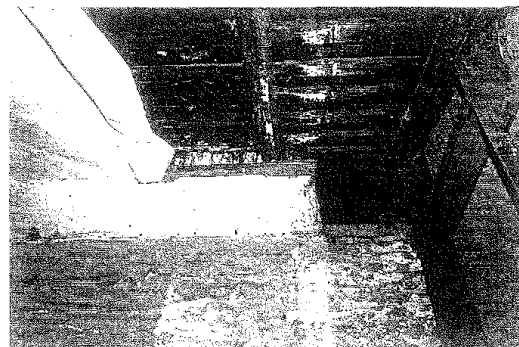
Figure 38:
View to ceiling space above
bedroom 1. Crude laths in
foreground, limewash to inner
brickwork, nails to edge of sawn
rafters

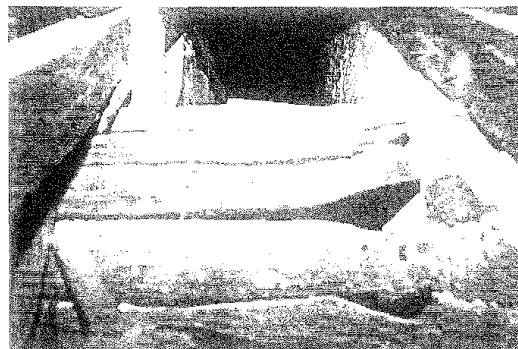
Figure 39:

The area shown in Figures 37 and
38 are now covered over.

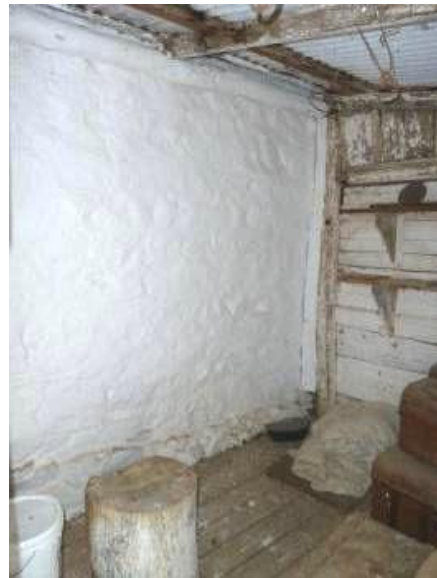
A crude timber wall constructed from bush rounds as framing with recycled pine boards as panelling. Short slabs infill above the plate and the wall has previously been limewashed. It was dismantled and faithfully reconstructed in 1990. The width of the central panel is indicative of a former doorway however all materials show evidence of their previous construction details and an interpretation of former use is difficult. Two timber shelves on timber brackets are affixed to the wall.

Figure 42:
East wall

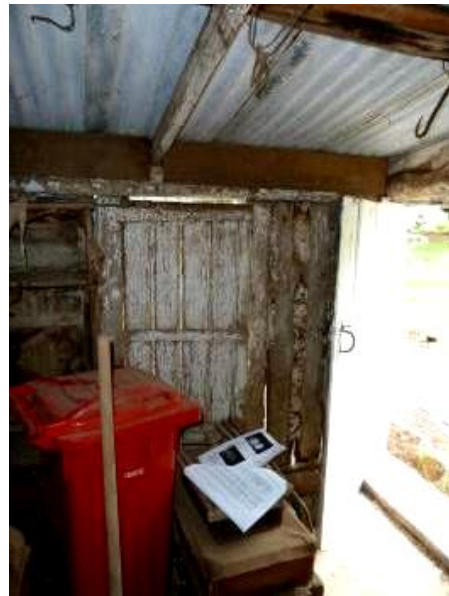
Vertical slab wall with rusted metal strips covering gaps between slabs. Some strips appear to be zinc, others have been cut from recycled tins. Base plate stabilised.

A centrally placed timber ledged door with five planks opens inwards to reveal a crude panel/door with netting insert. The original decayed base plate was replaced in 1990 with a new plate from a recycled telegraph pole.

Figure 43:**South wall***Source: EMA 2011*

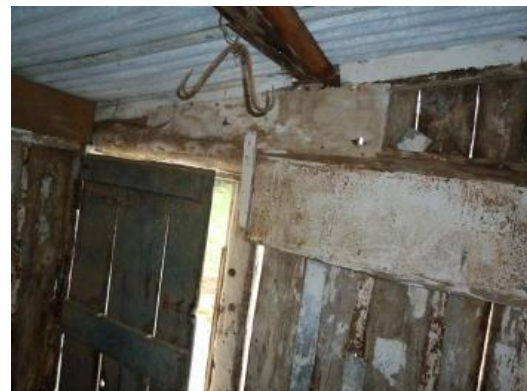
A slab wall with timber ledged door with three planks at south end. The door has a metal latch. The introduced base plate has been rebated to accommodate the (later) door. Flattened kerosine tins, or the like, are affixed to part of the wall with heavy paper above the upper slabs.

Figure 44:**West wall***Source: EMA 2011*

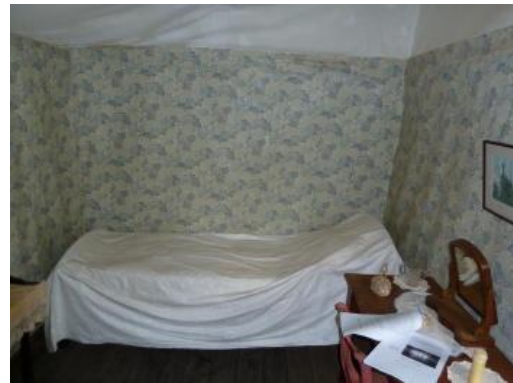
The west wall divides the bedroom from the adjacent meat room. It is only one leaf thick and is thus the real timbers seen from the meal room side. It is now lined with wallpaper.

Figure 48:
View of west wall.

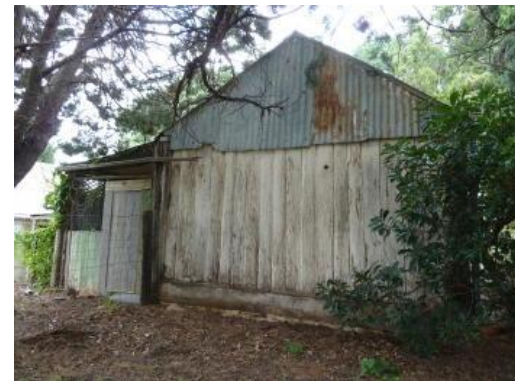
**Kitchen Building North
Elevation**

The kitchen building is a free standing slab structure linked to the stone cottage via a stepped path and with a corrugated iron roof. A verandah on the east face may have enclosed a former wet area.

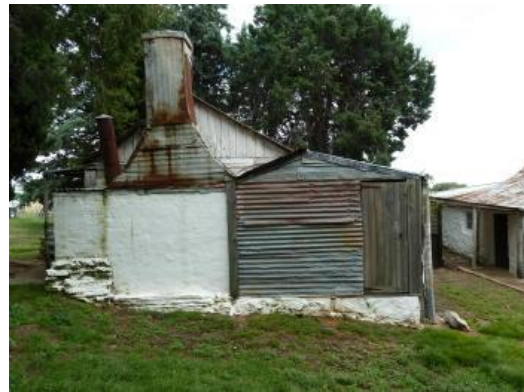
Bread-oven at the west end is set upon a stone base. The sandstock brickwork above appears integral with the fireplace. A stove pipe has been adapted to act as a flue. The fireplace chimney is of flattened corrugated iron adapted to fit the bush frame structure. Slab work has been used to close the gable end. The verandah alcove has been enclosed with recycled iron and an old door.

Figure 54:
South Elevation

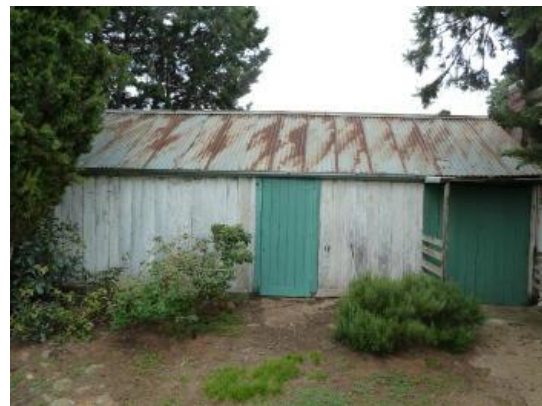
A vertical slab wall with new slabs to the northern end supported on a new timber plate. Posts at either side of this section contain rebates indicating former structures, possibly a skillion over part of this wall. The rebate and paint around the central door would likewise indicate a skillion here with some sort of structure attached to the post. This post has also been re-stumped. The skillion over the double doors has been reconstructed to former details and presumably post dates the introduction of the double doors and hence the adaptation to shearing shed. Similarly the rough cement paving would date from this time. The half round gutter to this roof is a recent introduction and replaces an earlier quad profile.

Figure 55:
West Elevation

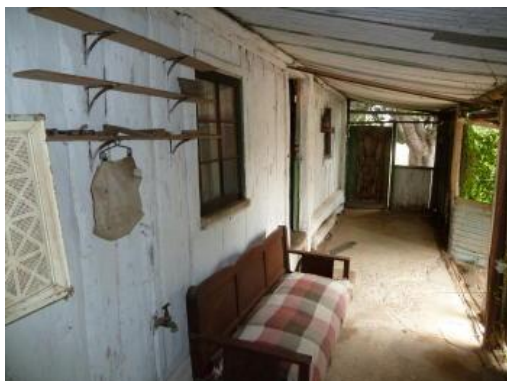
Presently a thin rough-cast concrete, breaking up in places. The age is not known but is presumed to be mid C 20th. The concrete has been poured on fill and shored up with crude stonework and logs. It envelops the original doorstep, being level with the lower step. There is no evidence of an earlier verandah floor. In the floor at the south end is a 50mm gal pipe, presumably waste. Traces of linoleum have been pressed onto the concrete at the far end, and in the adjacent alcove.

Figure 56:
Verandah Floor.

Note the tap and waste pipe.

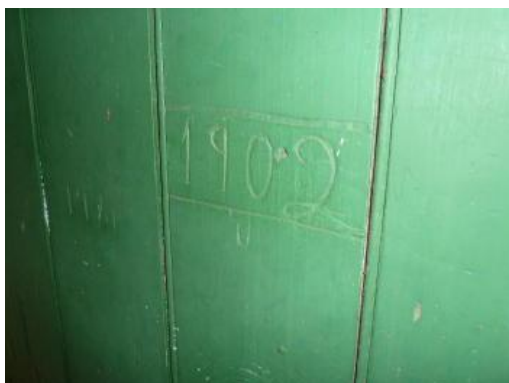
Figure 58:
Kitchen door detail showing date 1902

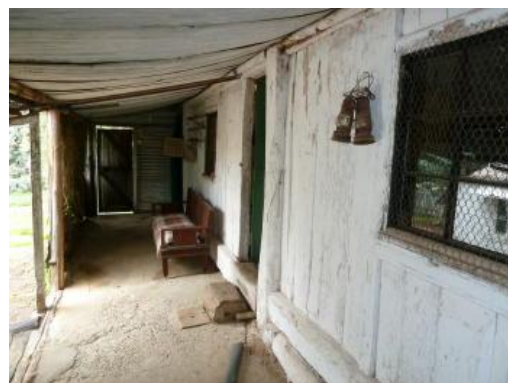
The west verandah wall is the external wall of the slab kitchen and dining room. Most of the fabric here appears to be original. There is packing beneath the base plates that would prevent entry of rabbits to the underfloor. The quality of the slab work is high and the fit of components very good. The walls have been whitewashed and retain details including a metal hook, assorted nails, shelving and plumbing fixtures. In the alcoves at the south end are the remains of what appears to be a toilet roll holder. Tar has been painted in front of the door (no evidence in 2011) and the threshold is well worn from use. Leather straps on the left doorjamb may have been the hinges of an earlier fly wire door. The upper plate has been trenched to receive slabs, and with the door open, an additional auger hole can be seen. The round plates supporting the corrugated iron are deeply rebated with an axe-cut to allow adequate penetration of the nails.

Figure 59:
Verandah wall.
Note whitewashed slab work and earlier hooks.

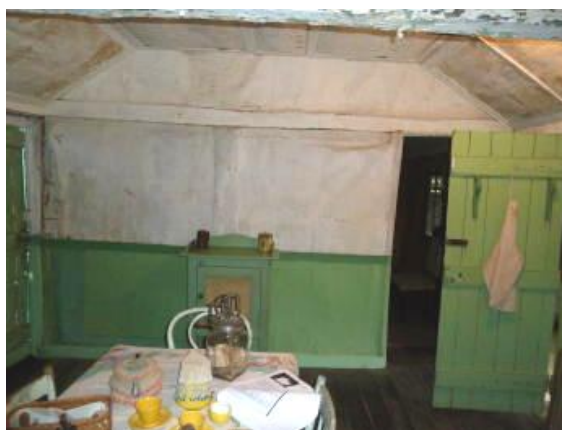
The wall was apparently added some time after construction and it can be noted that some floorboards carry through under the wall. The fabric of the wall is fragile and tearing at the base.

Kitchen north wall also showing patched and repaired flooring.

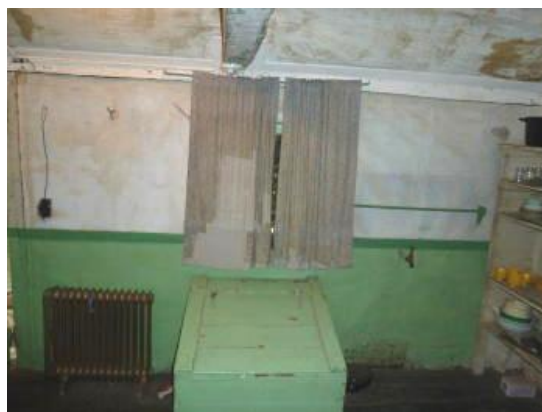
Painted paper as for the north wall with details including; bakelight light switch on door post, hook between door and window and wood box, handmade towel rail above tap, tap but no sink or drain. A large wooden box, apparently for flour, is located in front of the window. The timber ledged door with 6 planks has a felt pressure pad above the

The six pane sash is centre pivoted in the frame, there being no exposed jambs or architraves. Note that this sash is a relocated double hung window on its side.

Figure 62:
Kitchen east wall

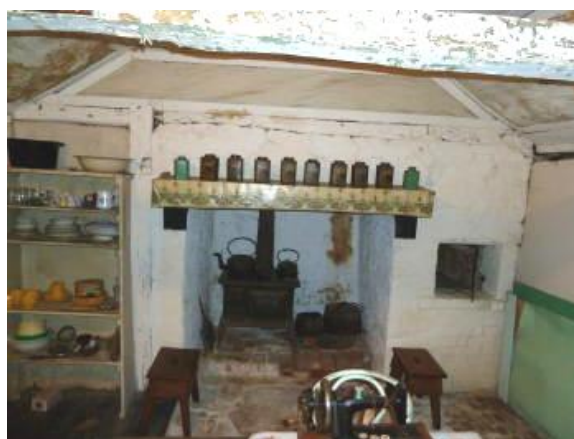
This wall contains a large centrally located fireplace opening of brick construction to approx 1,5m with a chimney constructed of bush timber and corrugated iron cladding. This frame had previously been damaged by fire. The firebox is heavily encrusted with layers of pipe clay.

A woodstove has been introduced to one side of the fireplace, and a metal plate allows open-fire cooking on the other. Black stains to the brick-work attest to its use. Several layers of sandstock bricks have been laid into the base of the fireplace. Some of these are fretting, as were bricks adjacent to the bread-oven (these were replaced in 1993 and can be identified by the brighter limewash).

On the face of the timber mantelpiece is an oilcloth valance with a koala bear motif in good condition. To the east of the fireplace is a timber post and slabwork covered by painted paper and a handmade set of shelves. To the west of the wall is a bread oven basically in sound condition although some internal bricks have collapsed. The masonry surfaces above the fireplace are heavily encrusted with flaking limewash.

Figure 63:
Kitchen south wall and stove alcove. Bread oven is to the right.

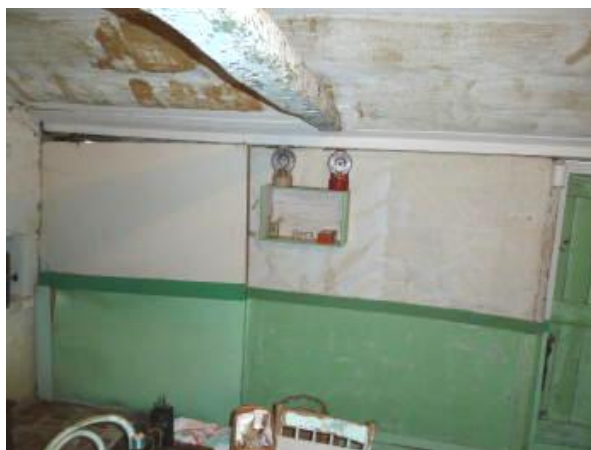
The west wall consists of former double doors at the south end, now lined with canite and plywood to match the rest of the wall, a single timber ledged door with 6 planks at the north end and a slab wall centrally that is lined internally with painted sheet metal below the dado and painted paper above. A recycled fruit box is mounted to the wall as a shelf.

On the north door the green paint is peeling to reveal the japanning underneath. The trenched top-plate may indicate this doorway was introduced sometime after the building was constructed. The base plate under this wall was replaced in 1993.

Figure 64:
West wall with double doors and sheep gate to the left, and Japanned door with peeling paint on right. Note fruit box as shelf.

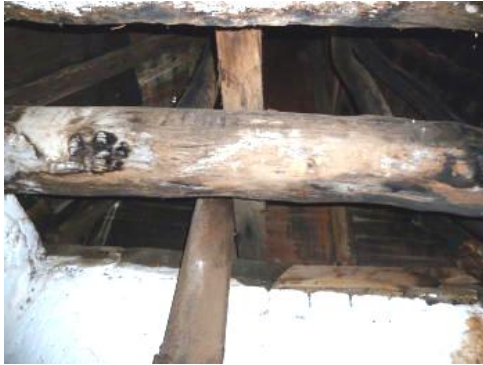
**Figure 65:****Internal view of chimney**

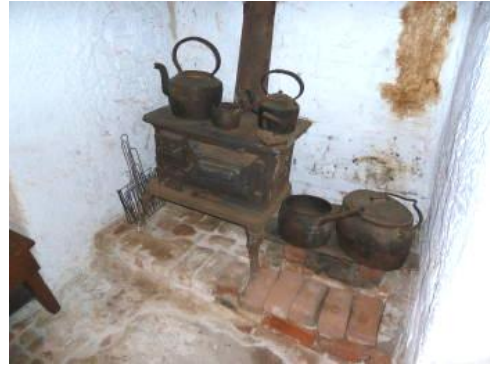
**Figure 66:****Stove alcove. Note heavy build-up of pipe clay.****Condition**

The building was conserved in 1993 and the condition is now stable. The floor has been patched. Rising damp has caused some fretting to the fireplace. The roof to the bread oven has fallen in.

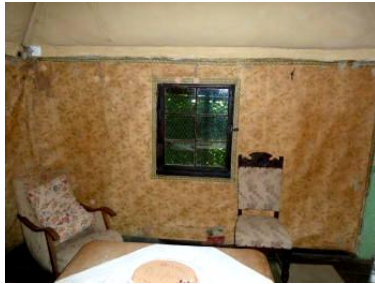
Paper finish as for the north wall. The six pane sash window is side hung. Note the wall paper border around this frame and the use of border paper adjacent to the kitchen post.

Figure 69:
East Wall

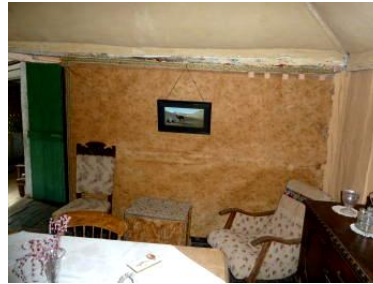
Patterned paper on a hessian base stretched over a timber frame wall, this wall is believed to be an infill. Traces of earlier wall paper are evident on the plate above. Note that some floorboards appear to continue under the wall.

Figure 70:
South Wall

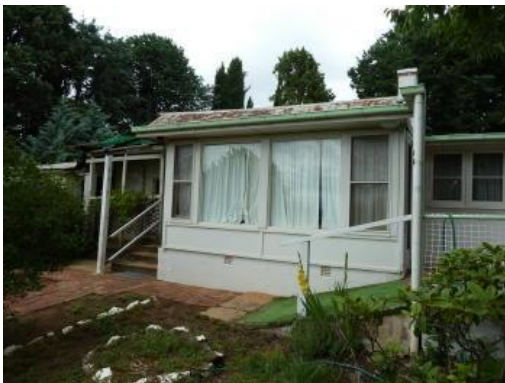
Built to the north of the cottage in about 1949, the flat is constructed from fibro and timber. There is a concrete porch with a fibro extension on the east side and a concrete path on the west. The flat, which appears to be in sound condition, is currently tenanted and electrical and water services are connected and functioning. The internal ceiling heights are approximately 2.1 metres, lower than present convention.

Figure 73:
East Elevation with flat to the right

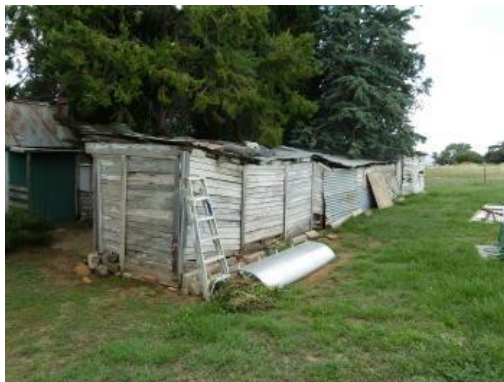
Figure 77:
North and west elevation

The shed is in poor/fair condition but may require regular future maintenance. The building is exposed to the north west winds and acts as a wind break for the rear of the precinct.

Mugga Mugga once contained a number of sheds and outbuildings, of which this shed appears the oldest remaining.

- Develop a conservation strategy for the shed. This is likely to involve major repair work including re stumping, re levelling, re roofing and reinstatement of loose fabric.
- It may be appropriate to introduce a storm water drain the western up-hill side of the shed.

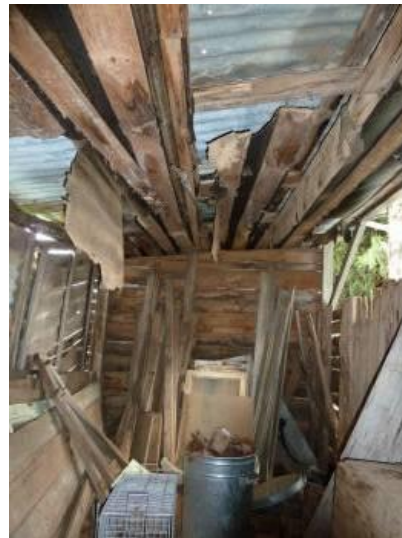
Figure 80:
Central section of the shed view north.
Note the remnant paling fence on the
RHS, the dirt floor, and the tar paper
ceiling.

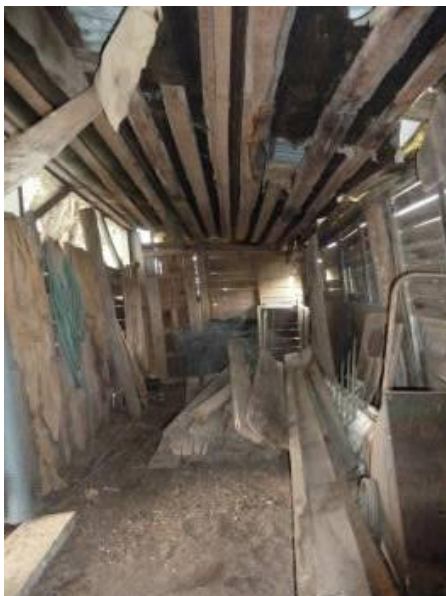
Figure 81:
Shed internal view, showing the paling
fence and pine flitch boarding externally
with cut-outs

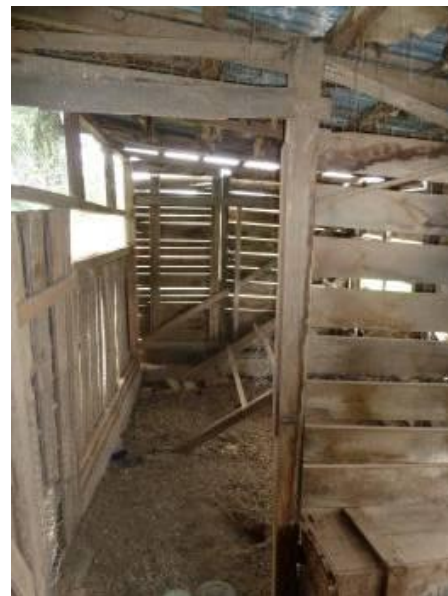
Figure 82:
Shed. Internal view north to chook house.
Note the hen perch.

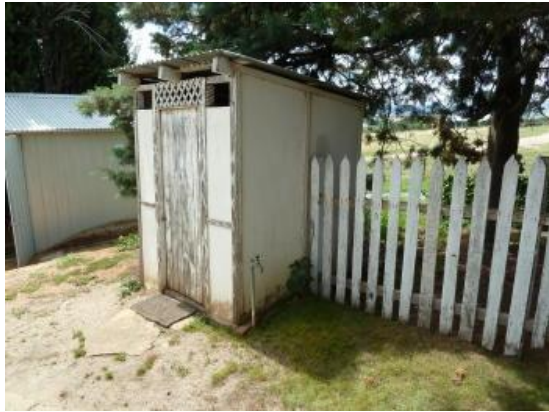
Figure 83:
Outside toilet, N/W elevation

An outside toilet with fibro cladding on a timber frame. The building is now closed up. Fencing and gardening tools are now stored inside. The toilet appears to have been an earth closet.

The building is in reasonable condition.

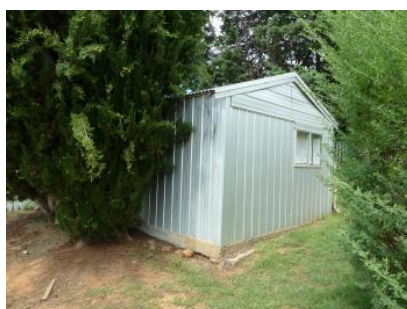
Figure 85:
Garage from north east.

A modern metal clad garage with corrugated metal gable roof occupying approximately the same site as the earlier garage that housed the car purchased by Evelyn Curley in 1926. The structure is in good condition and has some significance by virtue of the fact that it replicates the same function as the previous building that occupied this site.

The building has a concrete floor and includes an interpretative display. There is an aluminium framed window (on north side), steel clad access door to west and steel framed infill with translucent interpretative panels to former main door.

Gutter has been removed from the east side as it was displaced by the cypress.
